**ARCTIC  
RESPONSE  
TECHNOLOGY**  
OIL SPILL PREPAREDNESS

S. Potter, I. Buist, D. Cooper - SL Ross Environmental Research Limited  
W. Schnabel, J. Garron, R. Perkins, S. Aggarwal, R. Bullock -  
University of Alaska Fairbanks  
P. Lane - DESMI

**FIELD RESEARCH ON HELICOPTER APPLICATION OF  
CHEMICAL HERDERS TO ADVANCE IN-SITU BURNING**

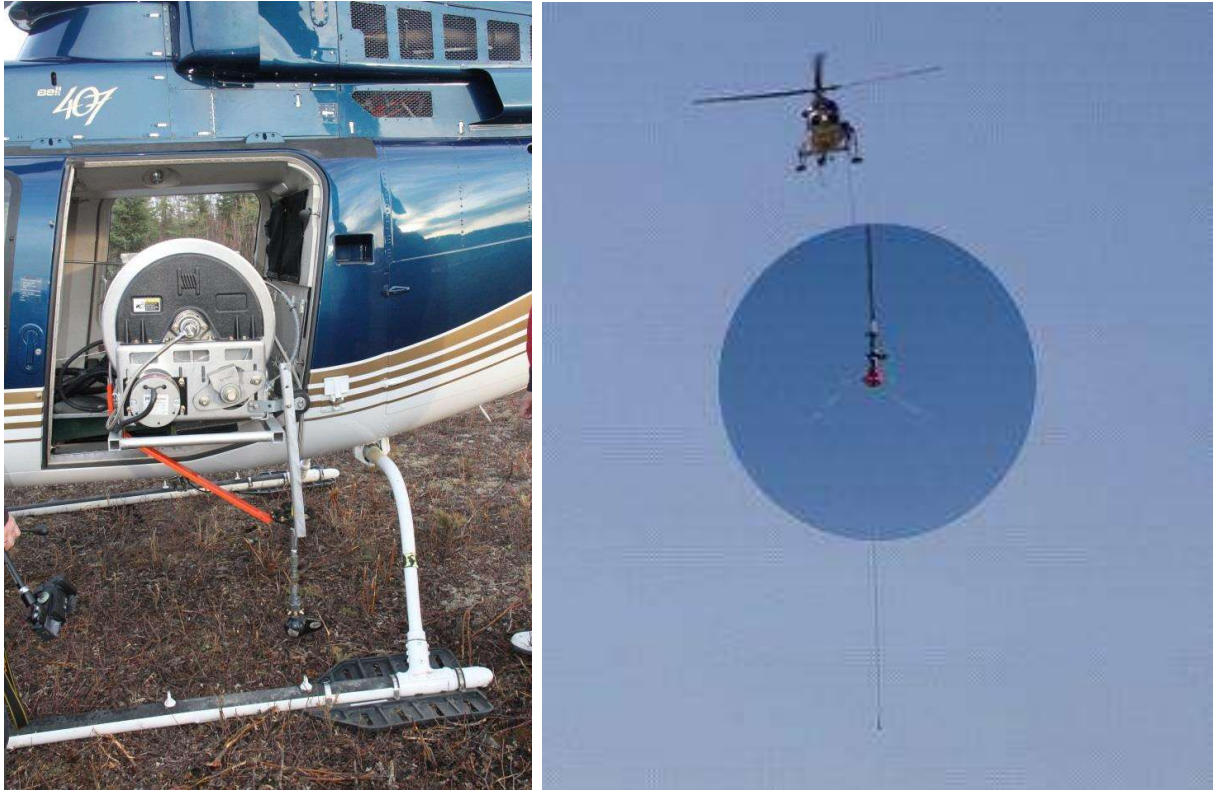
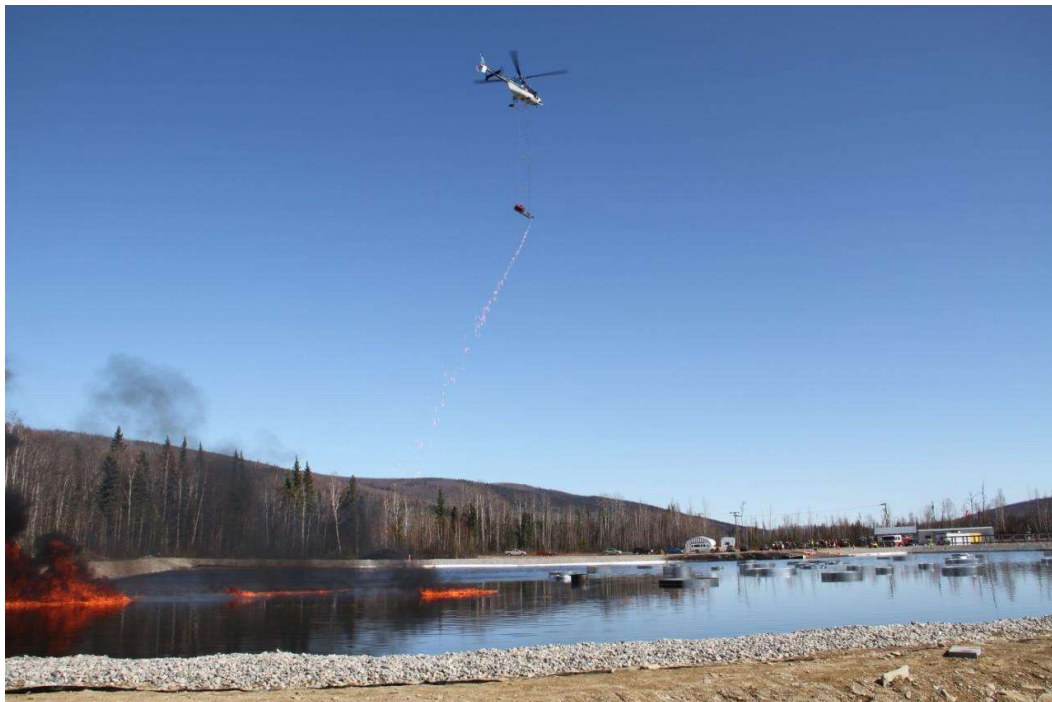
Figure ES-2: Herder application system mounted in Bell 407 and operating over basin

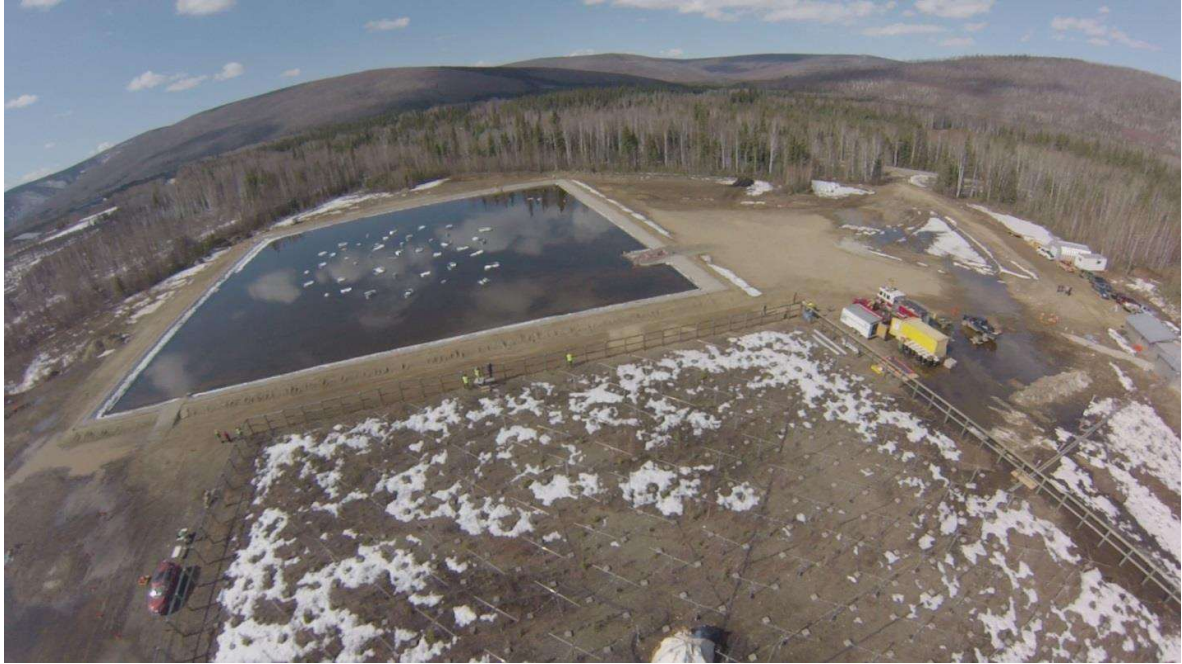
Figure 4: Aerial view of finished basin and site equipment locations

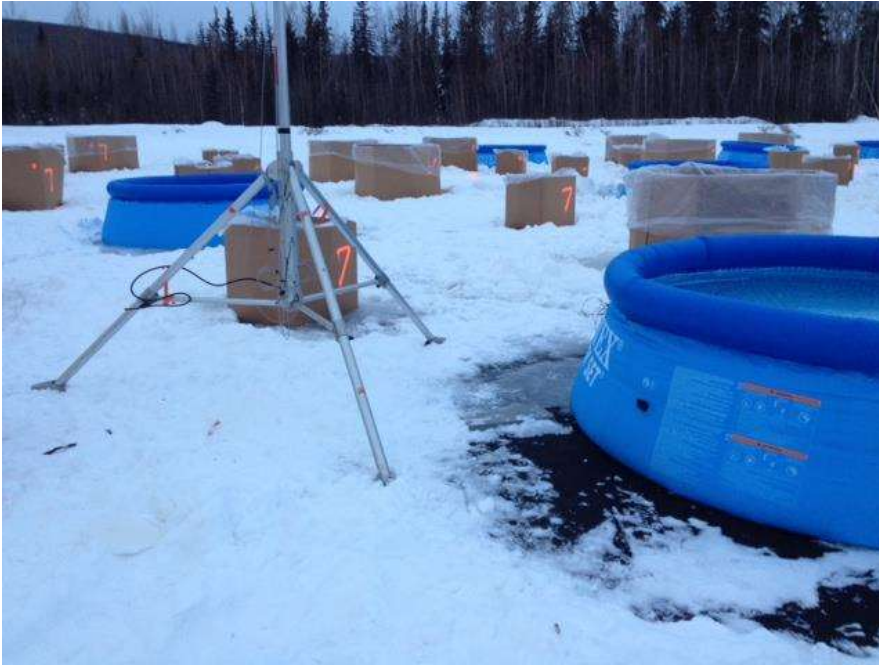
Figure 7: Cardboard boxes and children's pools used as forms to freeze water for ice floes

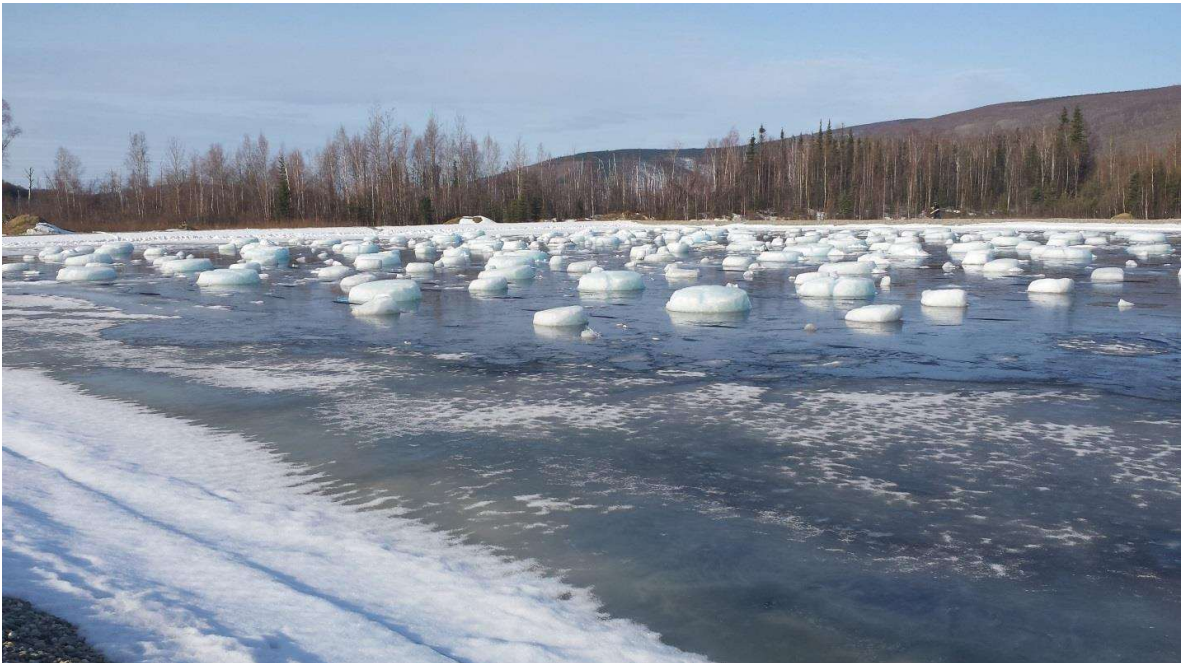
Figure 8: Ice floes in basin just before addition of water

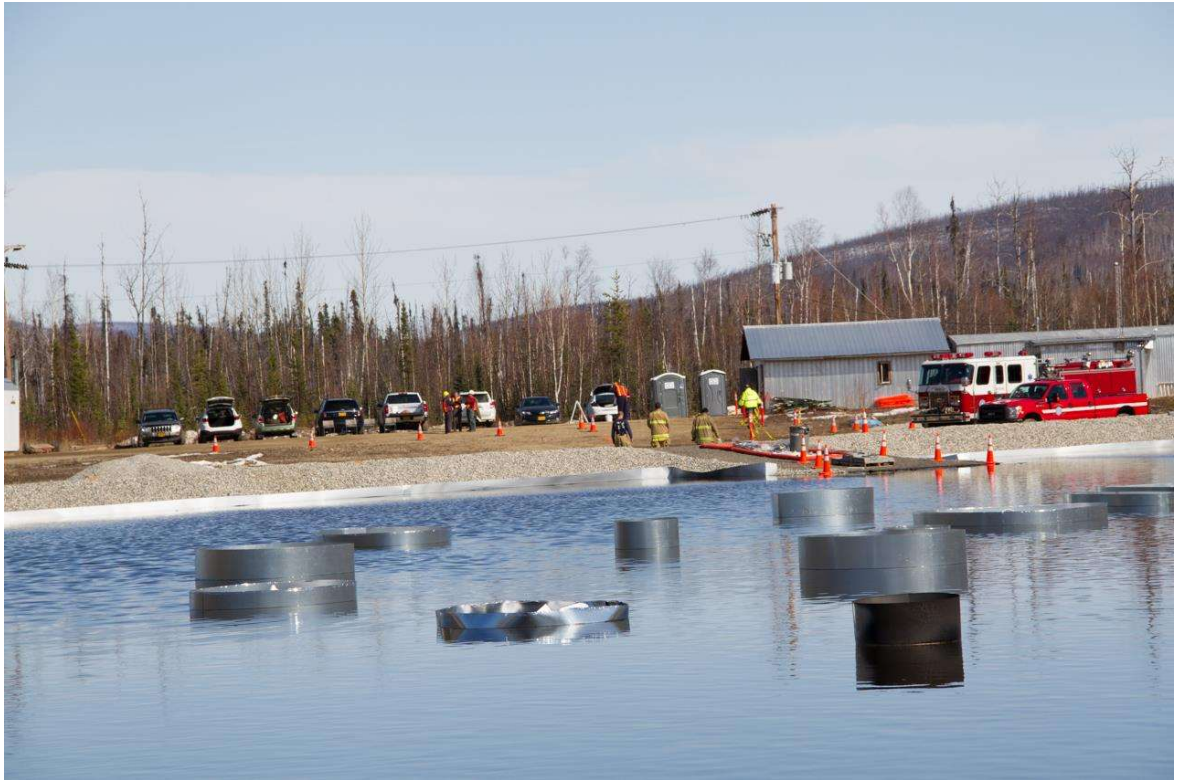
Figure 9: Sheet metal "faux" floes constructed to replace melting ice

It rapidly became evident that the ice floes would deteriorate to such an extent as to be inadequate by the start of the tests, so alternative "faux" ice floes were created. Inasmuch as the main purpose of the ice floes was as a mechanical barrier to oil spreading, metal rings of various sizes were constructed to act as ice floe surrogates. Galvanized metal flashing in 2.4 m (8 foot) lengths were formed into rings using one, two, or three lengths to form circles with approximately 1 m, 2 m, and 3 m (8-, 16-, and 24-foot) circumference (**Figure 9**). Large pieces of white sorbent were placed inside the sheet metal rings to provide contrast for the aerial photography. The rings were placed within the central portion of the tank providing "ice" coverage of approximately 6% (**Figure 10**).

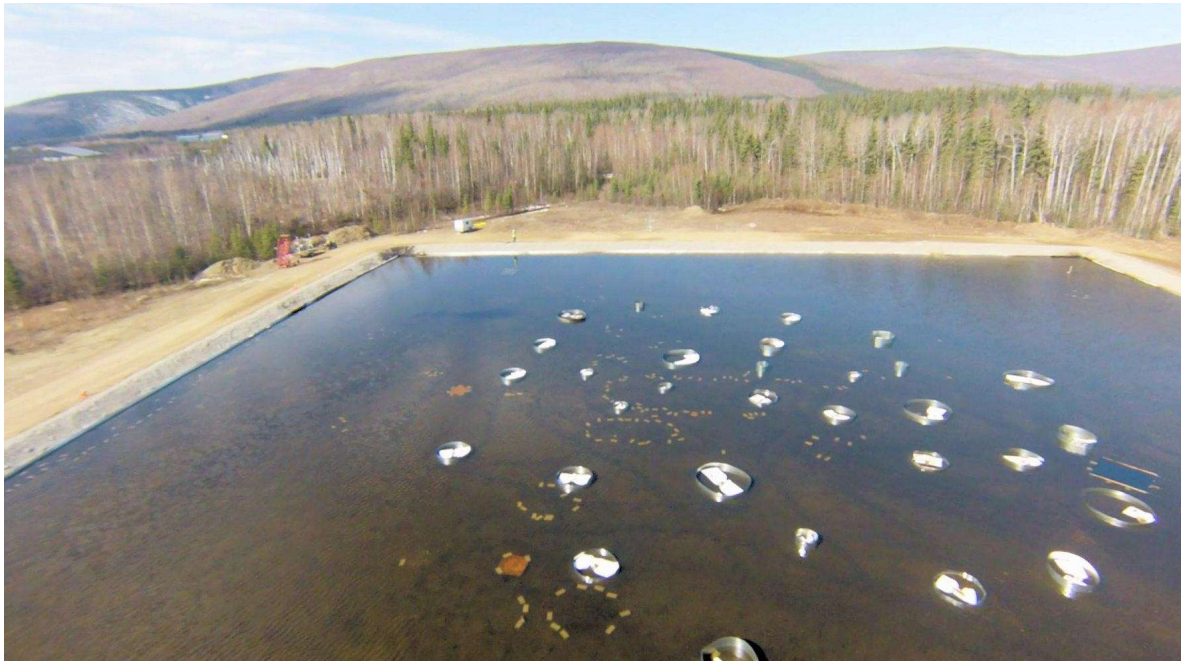
Figure 10: "Faux" floes in basin

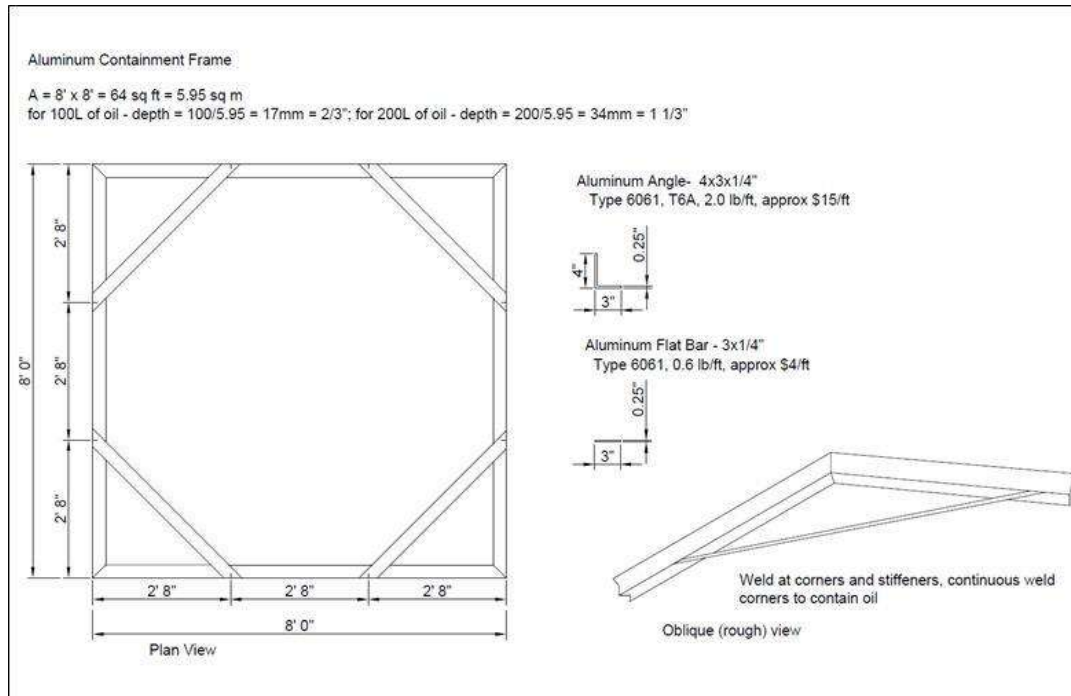
Figure 11: Aluminium angle release frame design sketch

square (**Figure 11**). The square was elevated by placing it on concrete paver blocks such that it had approximately 2.5 cm (1 inch) of freeboard. The selected volume of oil for each test, nominally either 100 or 200 litres, was then carefully poured into the ring (**Figure 12**). Stainless steel aircraft cable was attached to the frame and run to a position outside the basin at the upwind direction. When each test was initiated, workers pulled the cables to move the frame off its supports, dropping it below the water surface and causing the oil to be released (**Figure 13**).

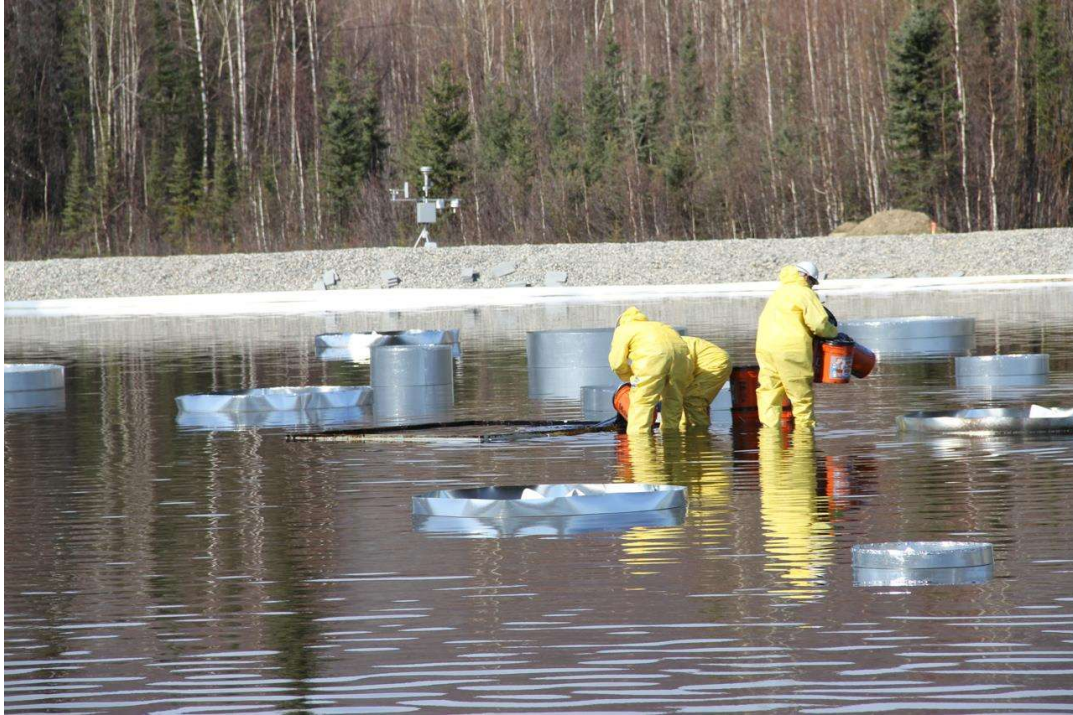
Figure 12: Pouring pre-weighed buckets of ANS crude into release frame in centre of "faux" floe field

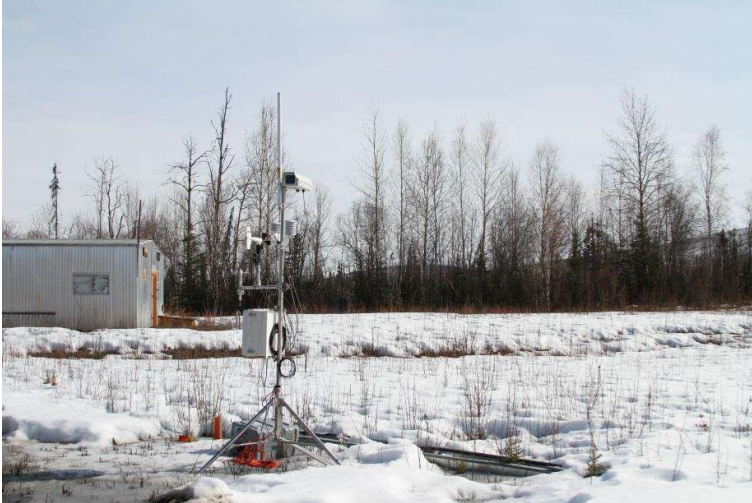
Figure 14: Portable meteorology station

shows the wind sock used for visual wind direction indication and flight operations attached to the corner of a storage container near the basin. The meteorological data collected during the tests is given in Appendix C. **Figure 16** and **Figure 17** show the air pollution samplers provided by the ADEC and used to measure the air before, during and after each test. These three samplers were positioned along a line perpendicular to the estimated drift direction of the combustion gases for each burn. The trailer-mounted samplers could be repositioned easily after the crude oil was ignited to increase the chance of collecting data from the plume. This data may be found in Appendix D.

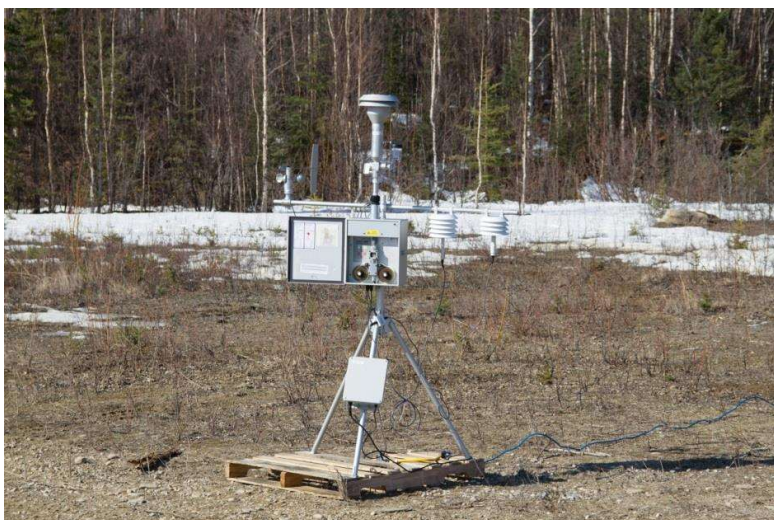
Figure 17: Stationary air sampler

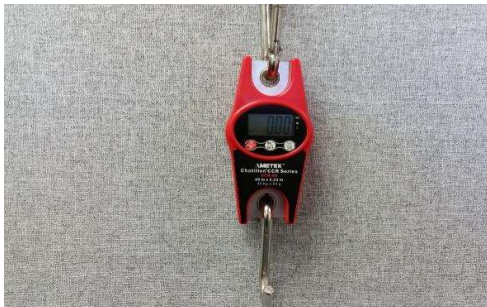
Figure 18: Digital Hanging Weigh Scale

To estimate the amounts of crude oil released for each test, the oil that had been delivered to the site in steel drums was pumped into numbered plastic buckets that were then weighed using a digital hanging scale (**Figure 18**). These buckets were subsequently carried out to the release frame and carefully poured into the frame using a spill plate to ensure that it did not splash or contact and stick to the basin liner (**Figure 12** above). Once a burn had extinguished, the burn residue and any unburned oil was carefully collected with pre-weighed sorbent, placed in a pre-weighed plastic bag and reweighed on a digital hanging scale (**Figure 19**). The losses of oil to evaporation were not measured.

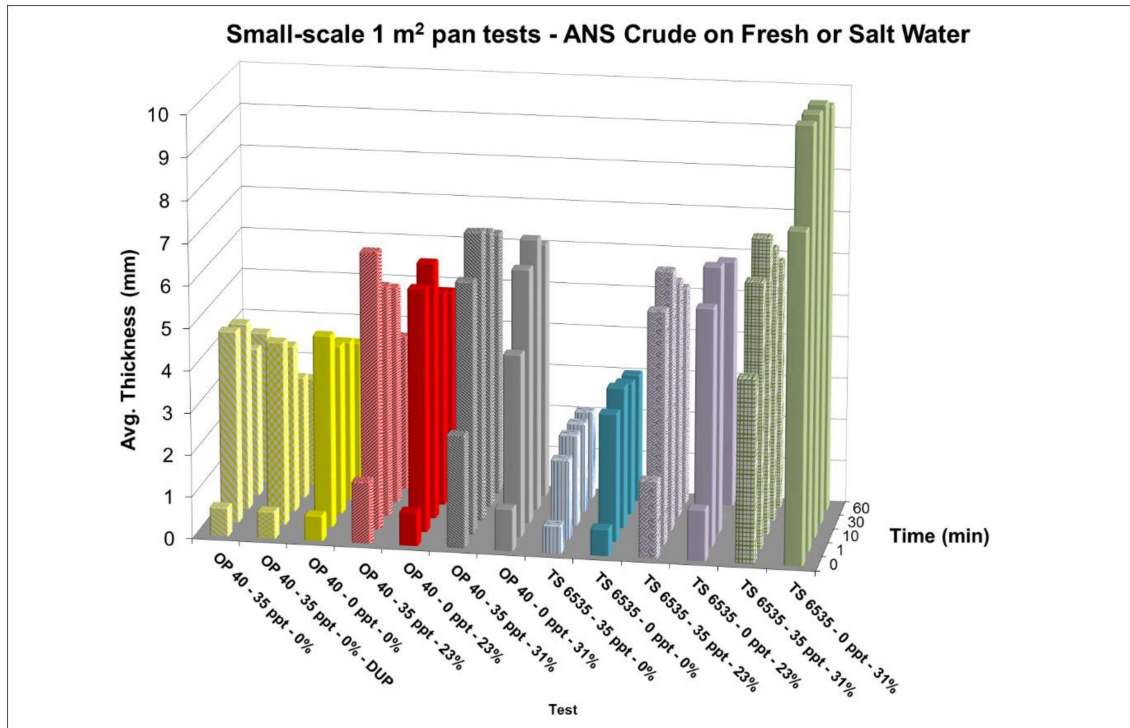
Figure 21: Laboratory Herder Test Results With Fresh ANS Crude

1. Both herding agents, ThickSlick 6535 and Siltech OP-40, were effective at herding fresh and moderately weathered oil.
2. Both herding agents, ThickSlick 6535 and Siltech OP-40, were similarly effective at herding oil on fresh and saline water. The large differences in herding effectiveness with the 31% evaporated crude are related to the oil's Pour Point (3°C) and not water salinity: the 31% evaporated oil gelled on the 0°C water.
3. Compared with previous herding studies with ANS crude, the herders were slightly less effective with the current blend of ANS, presumably due to slight changes in ANS composition.

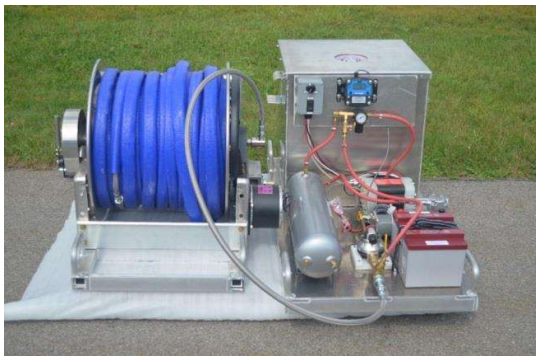
Figure 22: Initial Prototype Herder Application System Front

The DESMI AFTI herder application system was designed to transport and apply either OP-40 or ThickSlick 6535 from the open rear door of a commercial helicopter. The storage tank is insulated and carries up to 75 litres (20 US gallons) of herder. The system runs on 28V using aircraft quality components. It comprises two modules mounted on aluminium frames that are easily handled by two persons. The first module contains an extensible reel housing approximately 30 m (100 feet) of Stratoflex stainless steel hose with a Teflon liner. The second module houses an air-powered pump and air compressor capable of purging lines at the end of an application pass. It also contains a self-contained 28V battery array plus a 28V accessory cord for attachment to aircraft power systems, if available. Complete electrical circuit protection is provided with integrated circuit breakers, while multiple nozzles are enabled to adjust flow rate. The reel module with approximately 30 metres (100 feet) of hose has overall dimensions of 1.22m x 0.81m x 0.74m (48"L x 32"W x 29"H) and weighs approximately 91 kg (200 lbs.) when the hose is full of herder. The pump and tank module (see **Figure 22** and **Figure 23**) has overall dimensions of 1.22 x 0.61 x 0.61m (48"L x 24"W x 24"H), and weighs 84 kg (185 lbs.), plus up to 73 kg (160 lbs.) of herder.

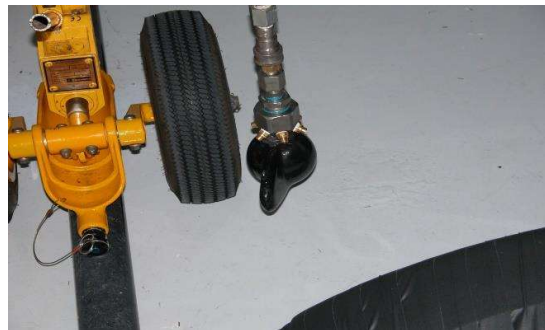
Figure 39: 5.5kg weight on end of nozzle

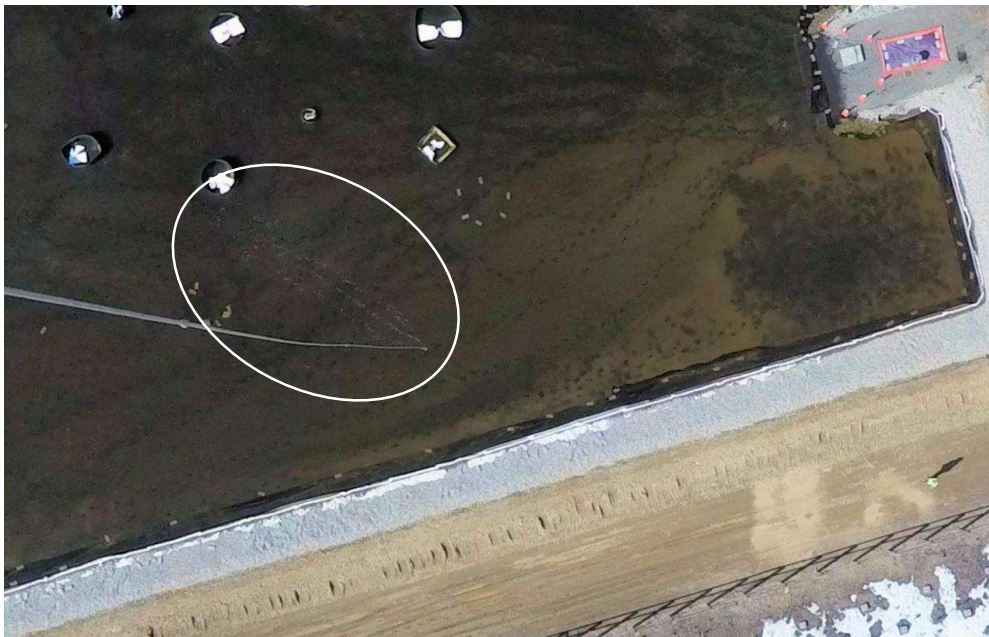
Figure 41: View from helicopter of herder spraying from nozzles (Test 1)

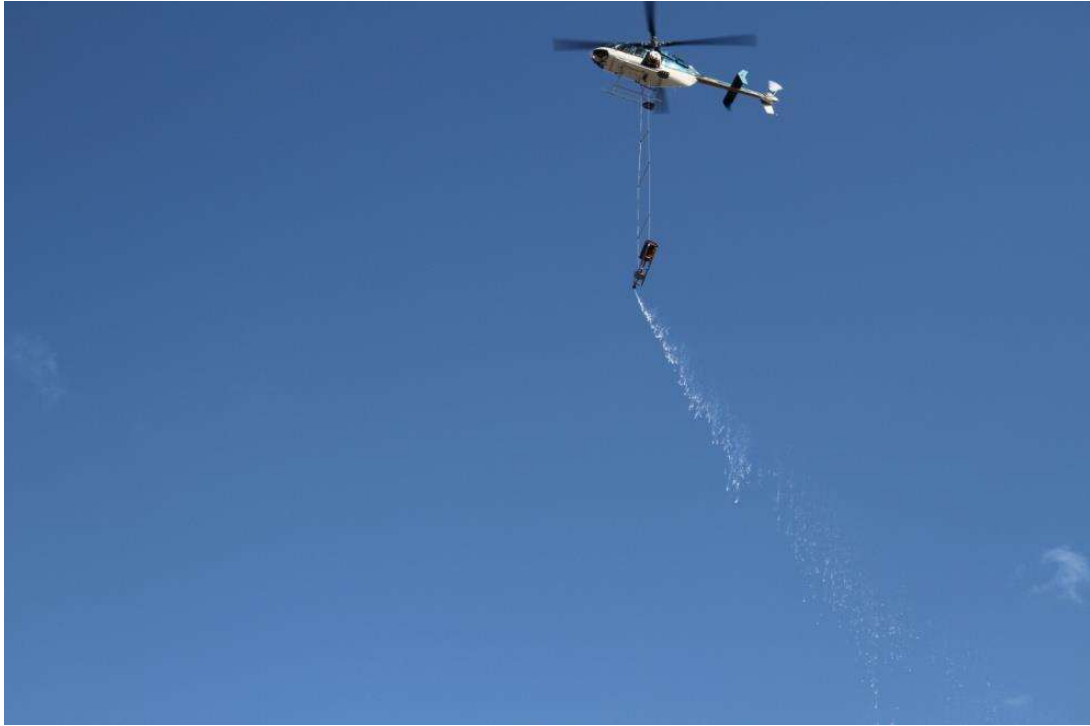
Figure 42: Diesel / gasoline mix failing to ignite from Heli-torch

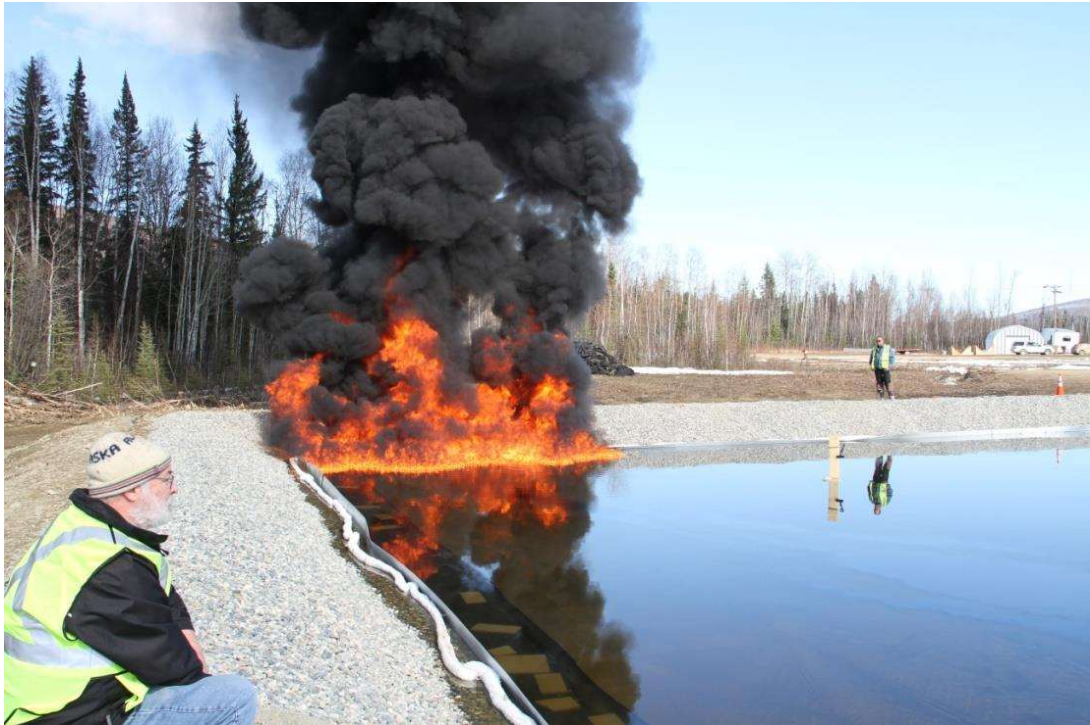
Figure 43: Crude burning in NW corner of basin (Test 1)

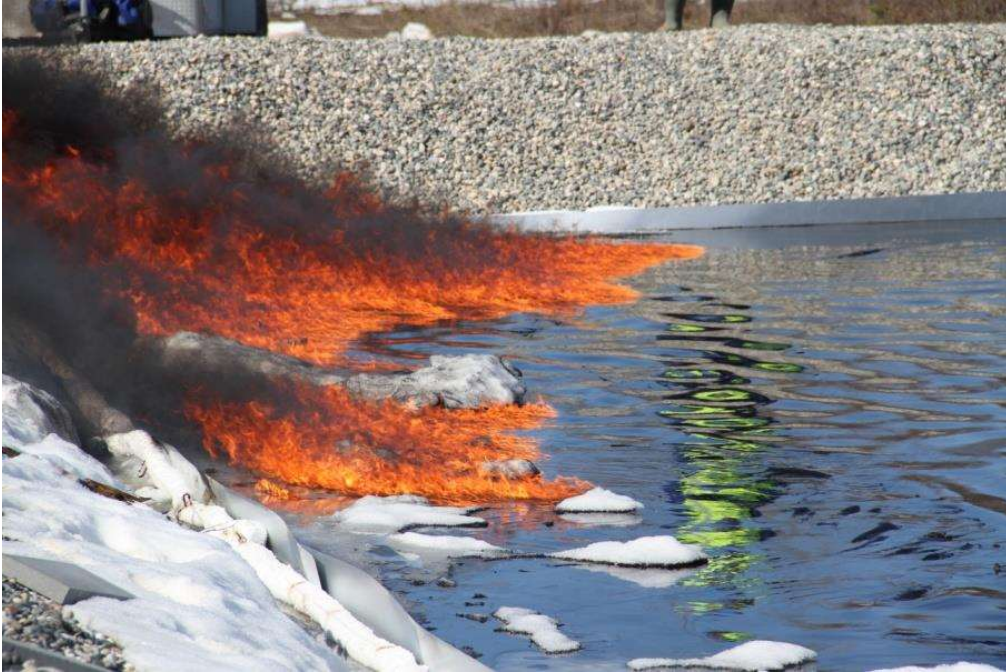
Figure 46: Test 2 burn in corner of basin

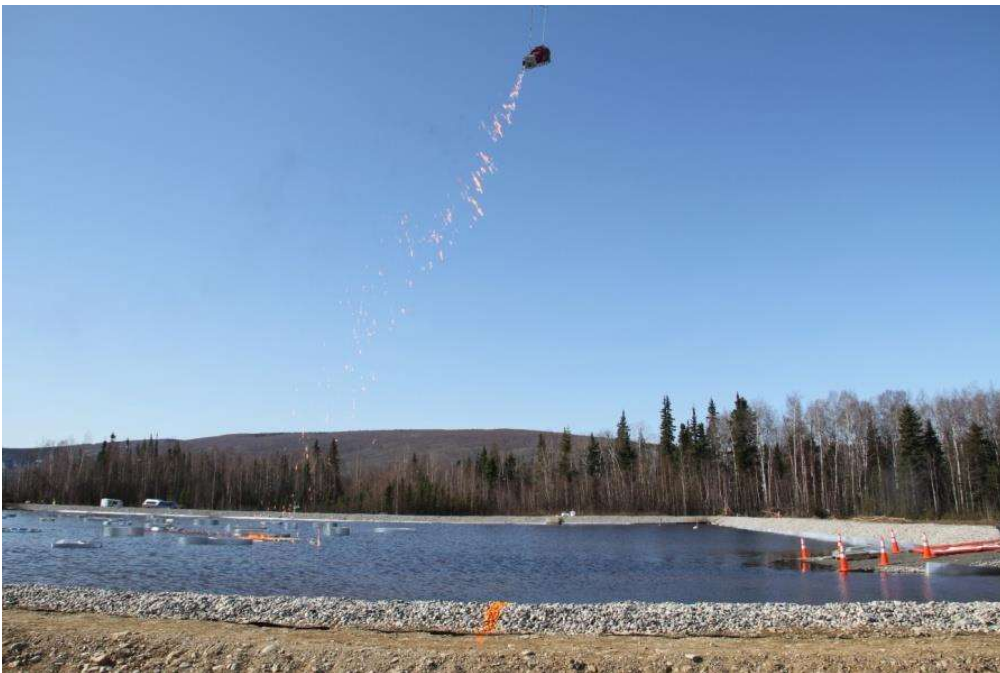
Figure 47: Successful Heli-torch test with 85:15 mixture of gasoline and diesel and longer gelling time

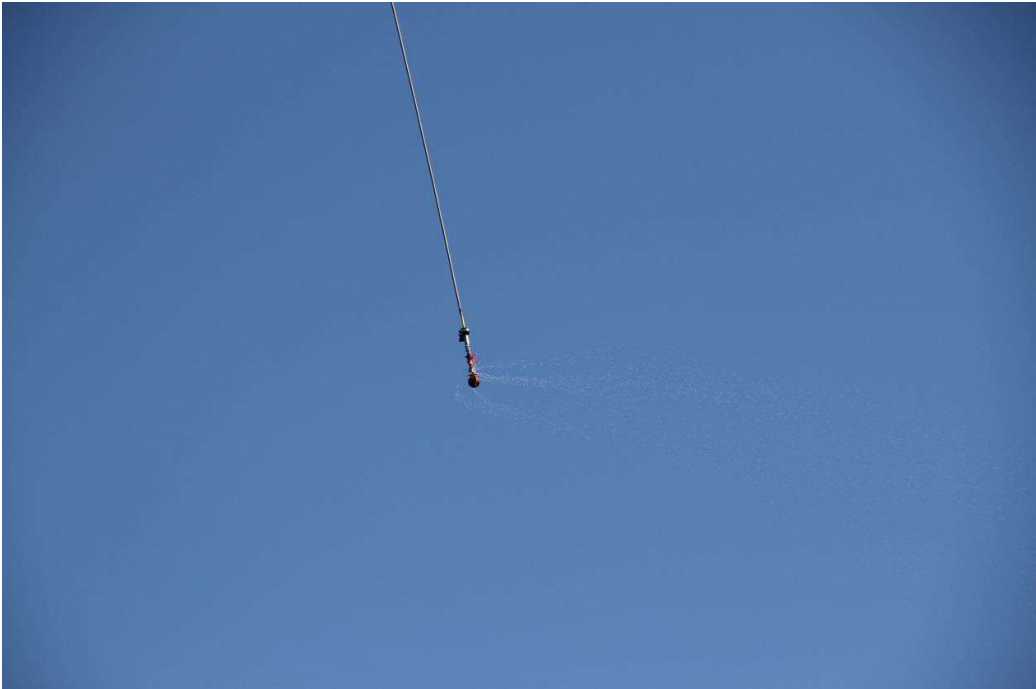
Figure 48: OP-40 spraying from nozzles in flight (Test 3)

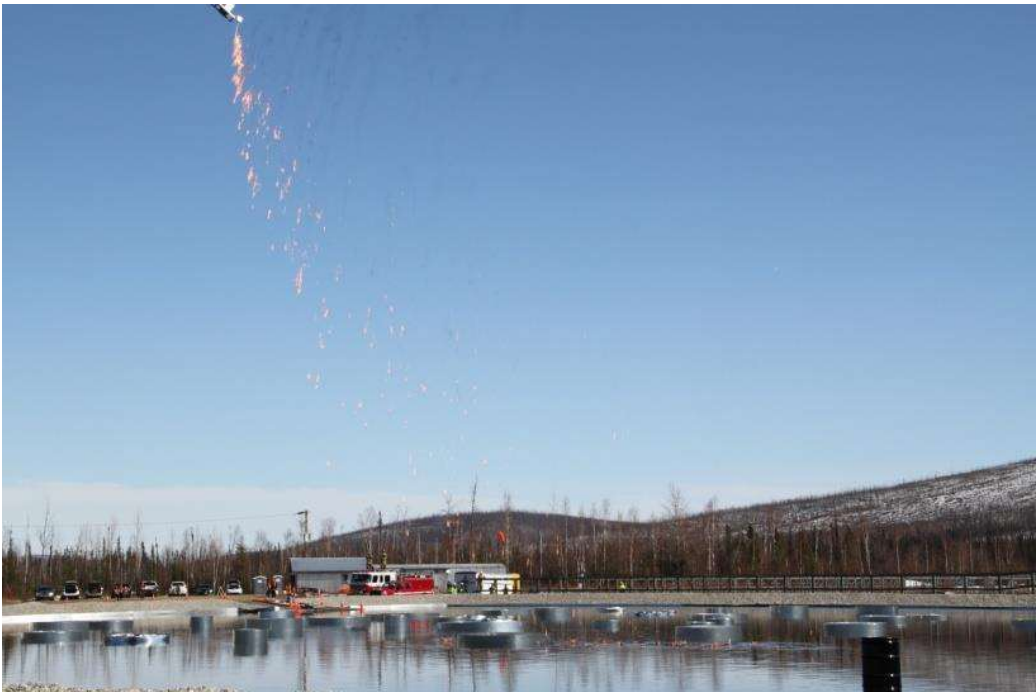
Figure 49: Burning gelled fuel hitting slick

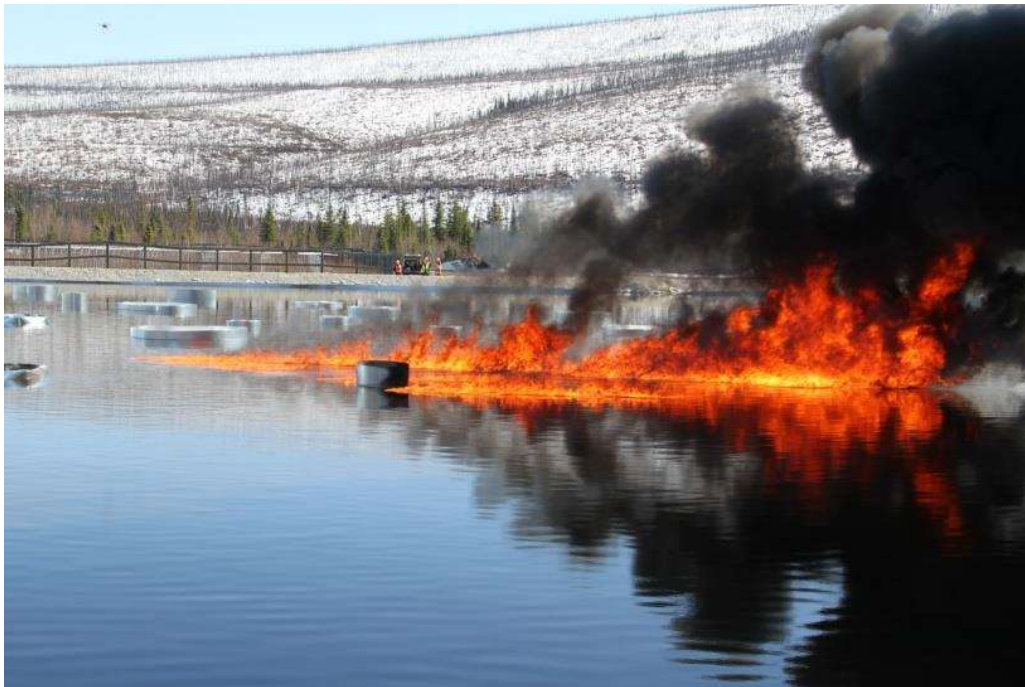
Figure 50: Test 3 Burn after first pass with Heli-torch

Approximately six minutes later, the helicopter returned with the Heli-torch loaded with a fully gelled 80:20 gasoline - diesel mixture and made a pass from south to north over the slick. The burning gelled fuel fell onto the slick (**Figure 49**) and ignited the herded oil (**Figure 50**). A robust burn proceeded (**Figure 51**), in the middle of the basin, away from all the basin walls. Once the initial burn had died down the pilot made a second pass over the slick and ignited another portion of the slick. Only a weak burn was initiated. About three minutes after the second ignition, the leading edge of the ignited slick reached the edge of the basin, and the fire intensity increased. The remainder of the burning slick drifted to the west corner of the basin and continued to burn intensely in a small area (**Figure 52**) until the remaining oil extinguished. It was apparent as the slick remnants approached the edge of the basin that the herder was acting on the slick, even after burning. The following link plays a video clip of the burn, from ignition to extinction, compiled from video taken from various locations: [RUN 3 VIDEO](#)

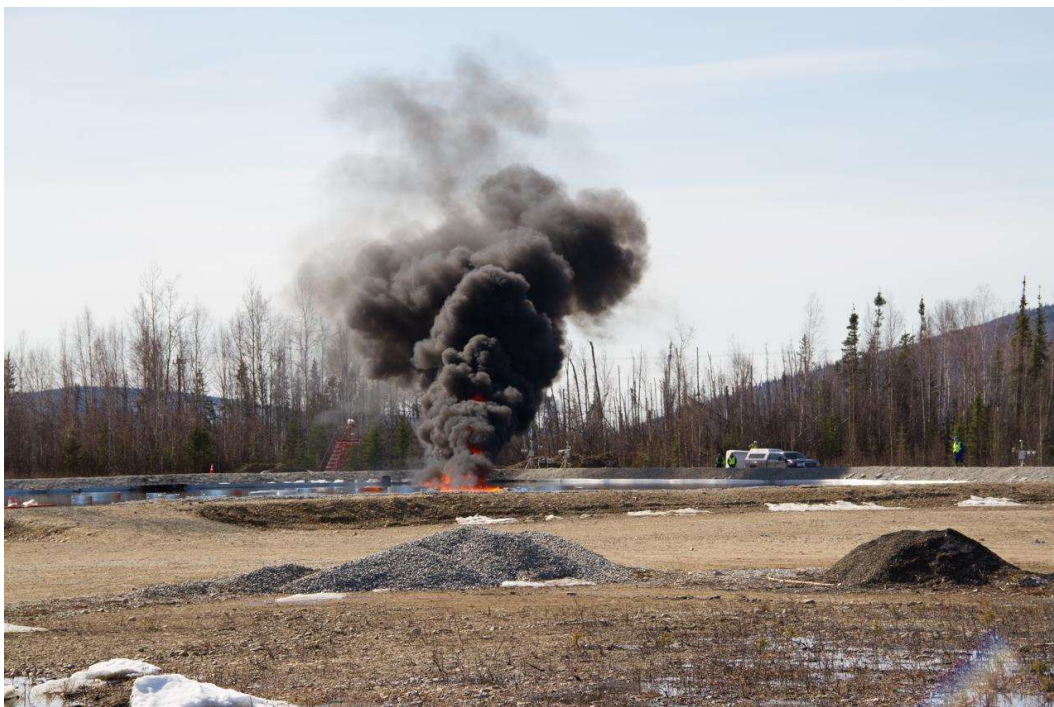
Figure 51: Slick burning in middle of basin (Test 3)

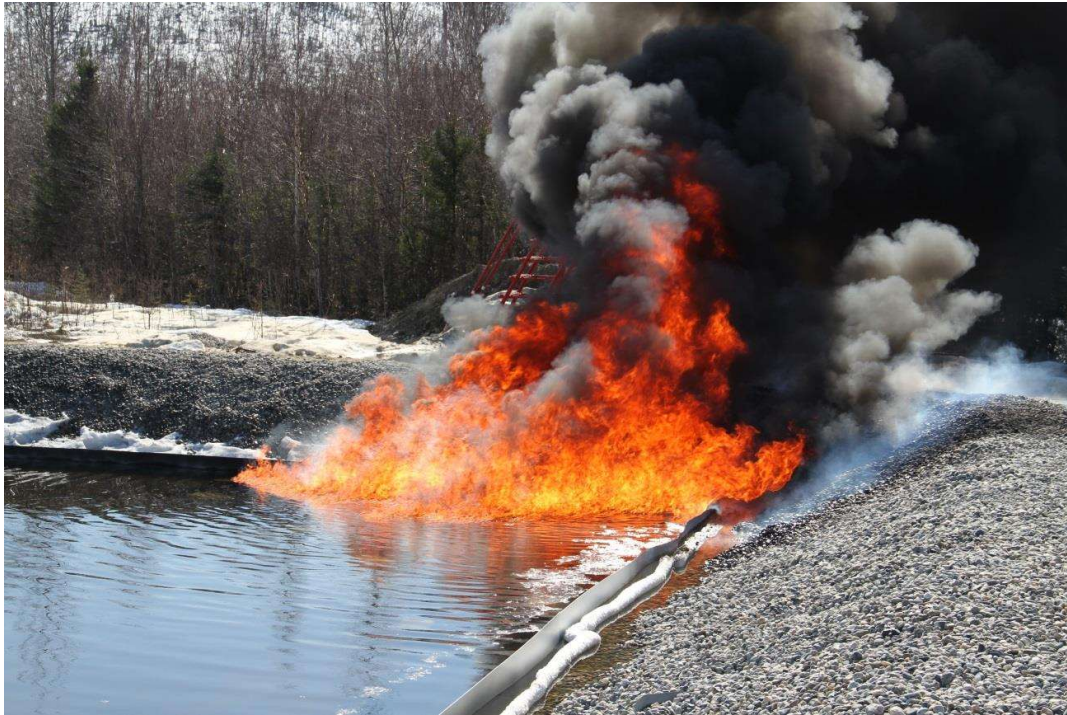
Figure 52: Oil burning in west corner of basin at end of Test 3

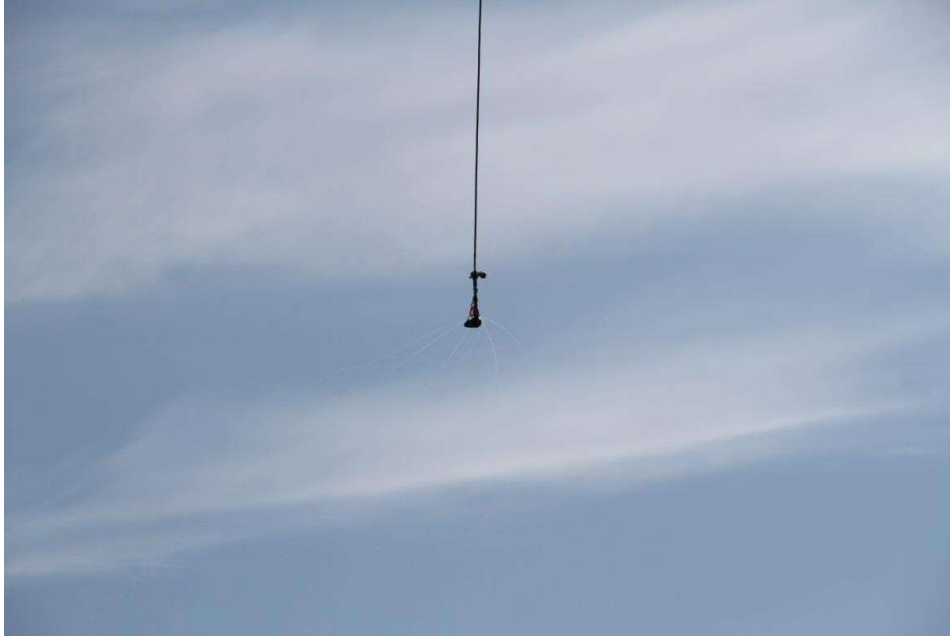
Figure 54: Herder streaming from nozzle when air pressure used to purge system at end of Run 4

After Test 4 was complete, a set of bench-scale experiments with the herding agents were undertaken to determine the possible causes of incomplete herder deployment during Test 4. Based on these tests, it was discovered that when a small amount of water was added to OP-40, it almost instantly became a viscous gel. The same, but less dramatic, behaviour was noted when a small amount of water was added to ThickSlick 6535. Additional bench-scale tests indicated that diesel fuel mixed with the herders did not cause gelling later tests indicated that iso-propyl alcohol mixed with the herders did not cause gelling either.

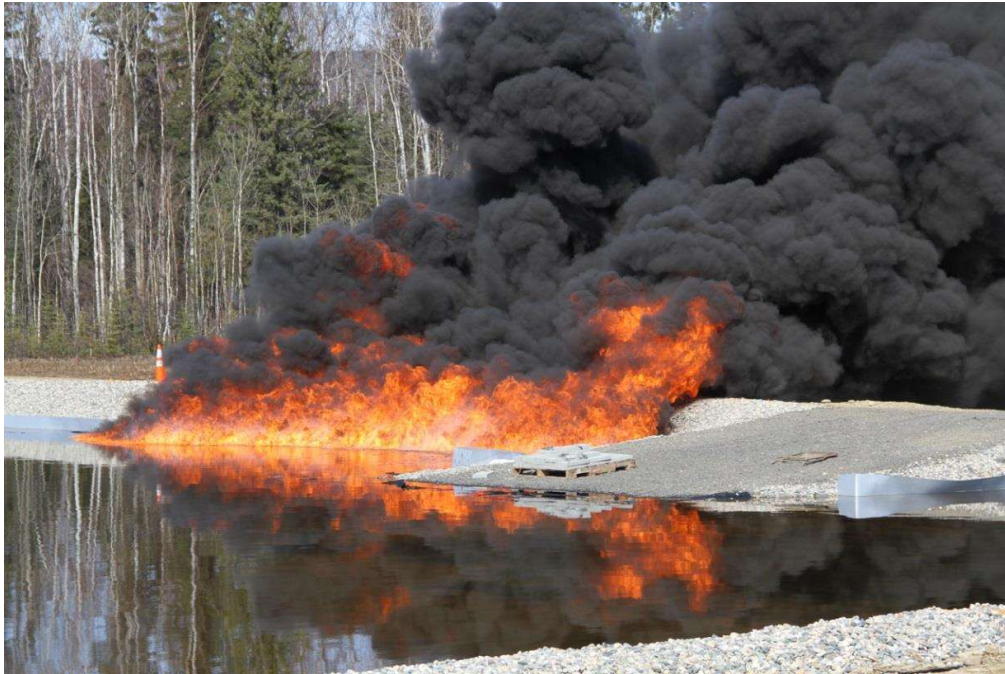
Figure 56: Burn against ramp and northeast sidewall of basin (Test 4)

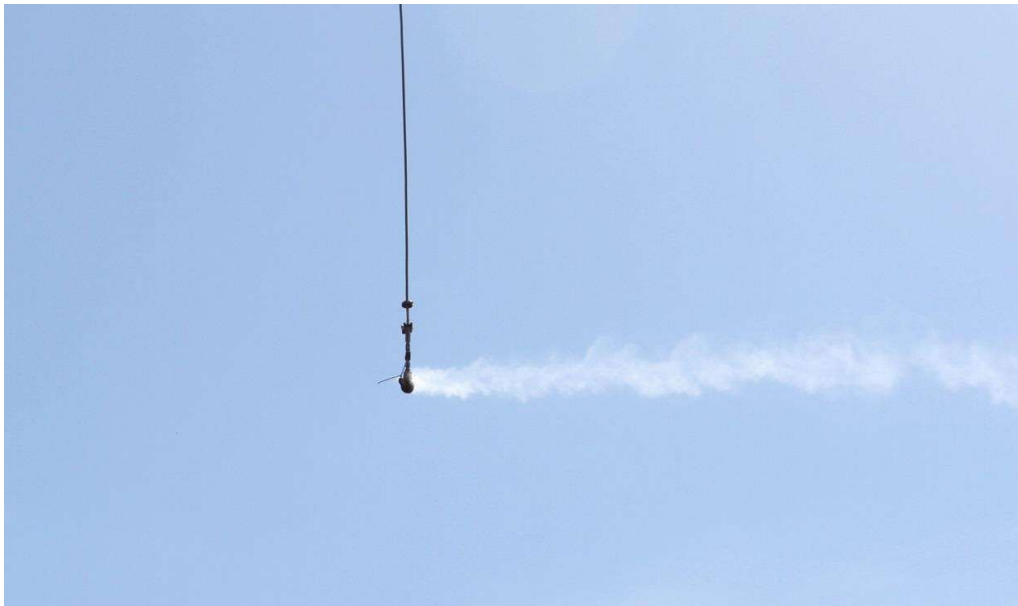
Figure 57: Good atomization of TS 6535 during Test 5 application

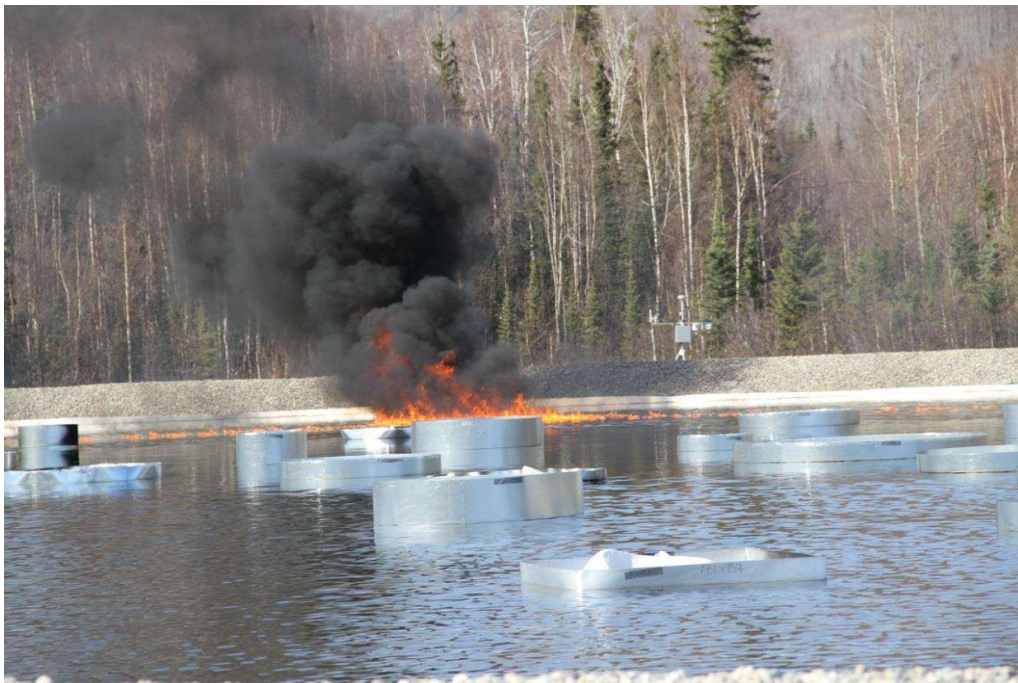
Figure 59: First burn of Test 5

Approximately six minutes later, the helicopter returned with the Heli-torch loaded with a fully gelled 80% gasoline / 20% diesel mixture and made a pass from south to north over the slick. The burning gelled fuel fell onto the slick (**Figure 58**) and ignited it. A robust burn proceeded (**Figure 59**) away from all sidewalls. After the first burn subsided, the pilot made a second pass over the slick after circling around and ignited another area. A second robust burn was initiated (**Figure 60**). It was observed that when the pilot hovered over the northeast side of the basin to empty the Heli-torch of gelled fuel, the rotor wash affected the flames of the adjacent burning slick. Initially, burning occurred away from all sidewalls, but eventually after the second ignition, the burning slick drifted to the west corner under the influence of the wind, where some burning continued as the slick collected against the sidewall. The following link plays a video clip of the burn, from ignition to extinction, compiled from video taken from various locations: [RUN 5 VIDEO](#)

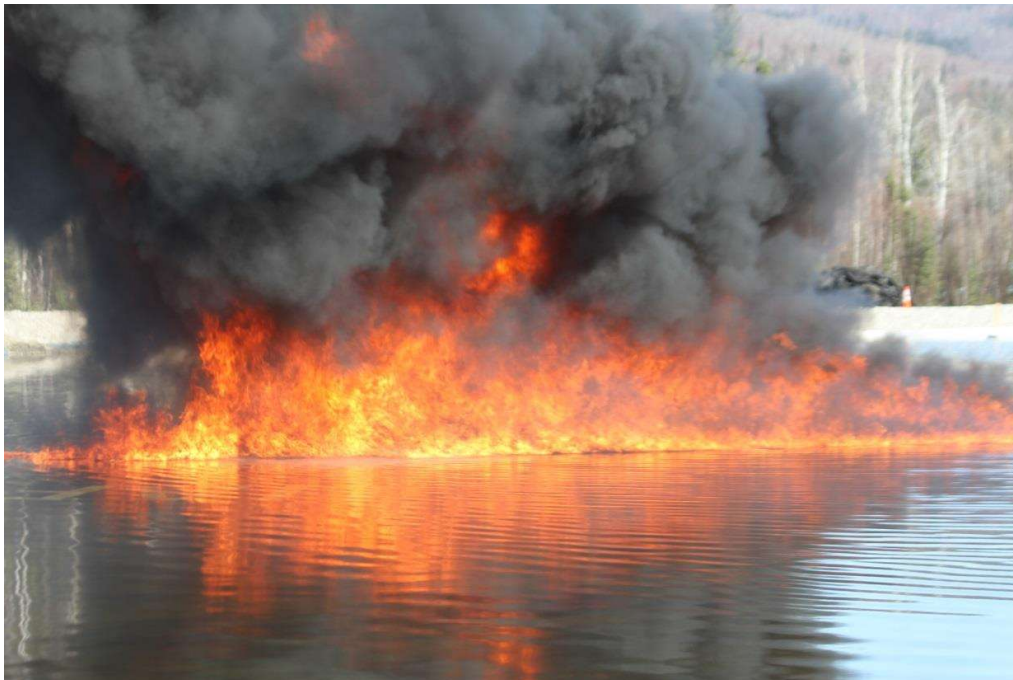
Figure 60: Second burn of Test 5
