**ARCTIC  
RESPONSE  
TECHNOLOGY**  
OIL SPILL PREPAREDNESS

S. Potter, I. Buist, D. Cooper - SL Ross Environmental Research Limited  
W. Schnabel, J. Garron, R. Perkins, S. Aggarwal, R. Bullock -  
University of Alaska Fairbanks  
P. Lane - DESMI

**FIELD RESEARCH ON HELICOPTER APPLICATION OF  
CHEMICAL HERDERS TO ADVANCE IN-SITU BURNING**

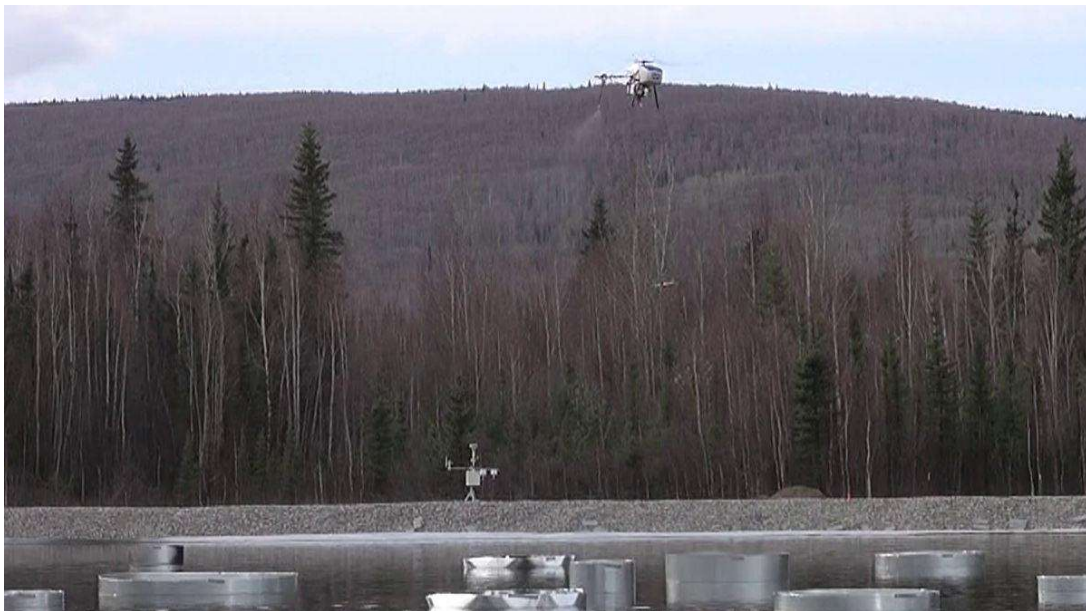
Figure 61: Responder UAV spraying water to simulate herder application

On the morning of Sunday April 26 the circuit board was installed and qualification flights were conducted from late-morning through 4:00pm at the “Balloon Inflation Area” of PFRR. The repaired UAV was transferred to the test basin and conducted a test run involving simulated herder application, followed by activating, then dropping a modified marine flare igniter. The herder application spray system worked well, when spraying water to simulate herder (**Figure 61**).

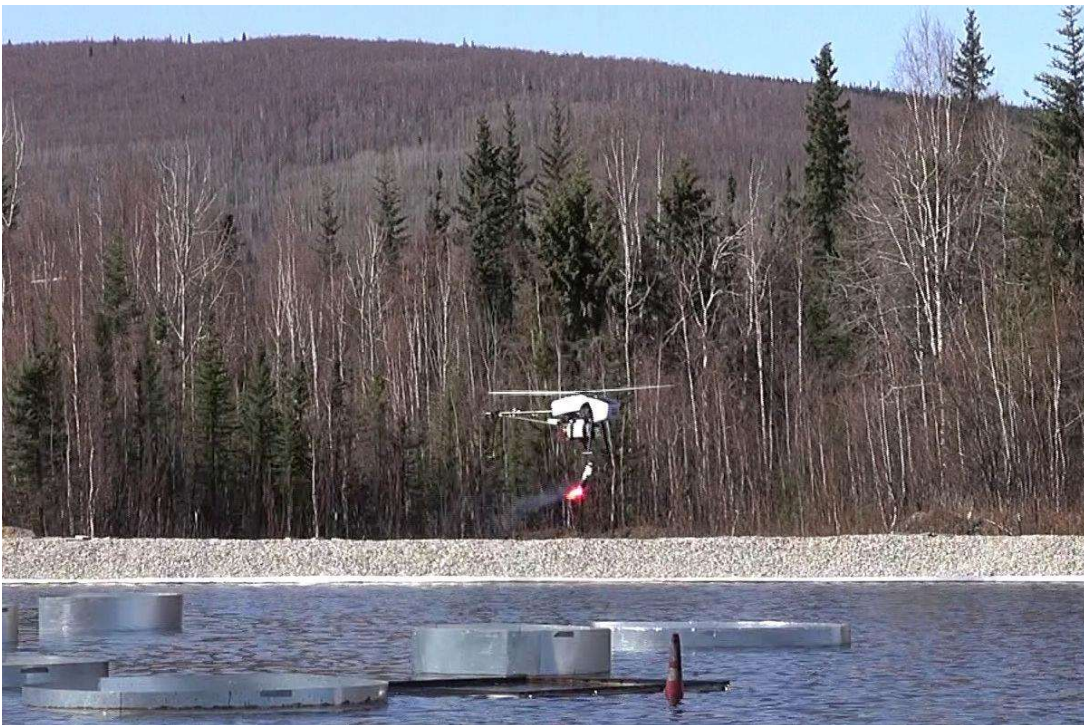
Figure 64: UAV Responder with active modified flare

A final UAV test, without oil, was conducted on Tuesday April 28. The targeting camera was reprogrammed overnight and made operational for the flight. The Responder was able to successfully fly with the herder application payload, then ignite and drop a marine flare within the target area (see **Figure 64** through **Figure 66**).

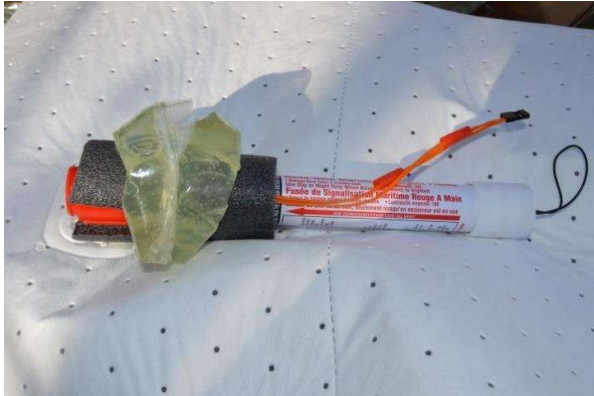
The fully assembled marine flare system with electronic match initiator, foam floatation, gelled gasoline, and counterweight embedded in the white cap in Figure 67.

Figure 67: Marine Flare based Igniter System

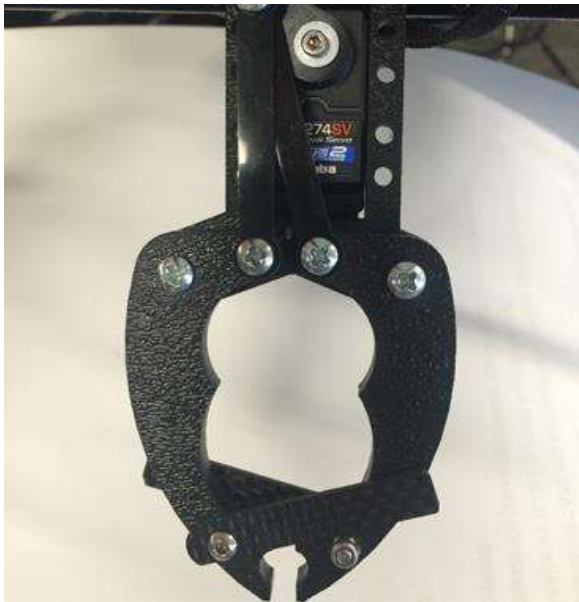
ING Robotics redesigned the igniter retention system (Figure 68) and initiated testing of loads well in excess of the expected igniter weight to ensure the servo controlling the system would not overheat. Roughly 100 tests have been completed with a range of weights between 0.2 lb and 2.2 lb without failure.

Figure 68: Retaining claw with redesigned retention bars

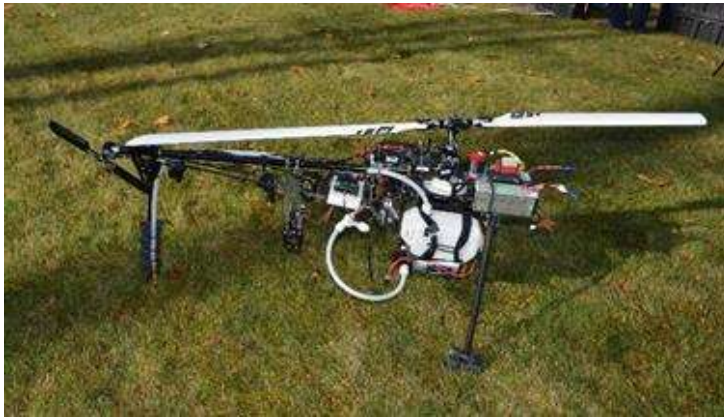
Figure 69: Responder with Herder Application System

Herder application testing was performed on November 3, 2015 under sunny conditions with temperatures ranging from 10 to 12 °C during the testing. Wind was from the northwest at approximately 15 km/h but did not pose much of a challenge for the UAV. Herder application passes were performed at altitudes in the 2 to 3 metre range, at speeds around 3 to 5 m/s. Figure 73 shows the UAV beginning one of the herder application passes, while Figure 74 shows the herder being sprayed from the application nozzle, with the Marine Flare Igniter System in the foreground. Figure 75 and Figure 76 show the results of the herder application on the oil trays.

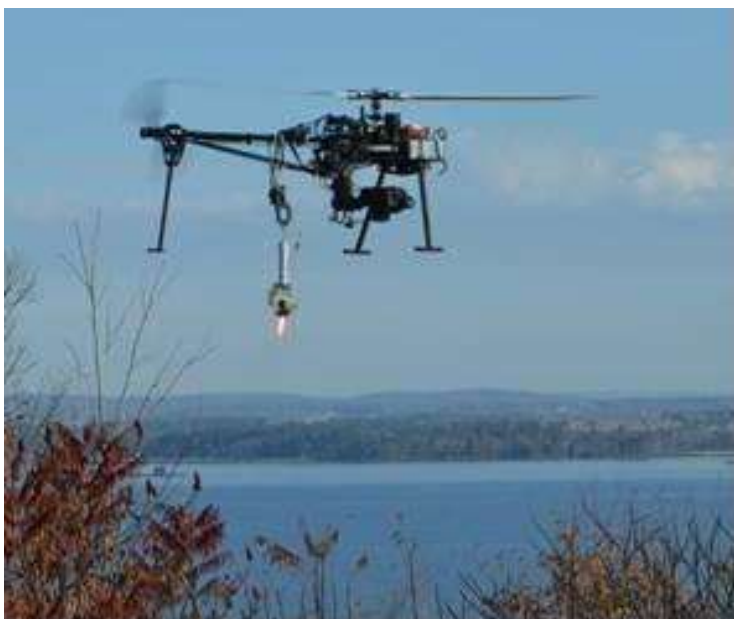
Figure 77: Responder triggering modified flare ignition

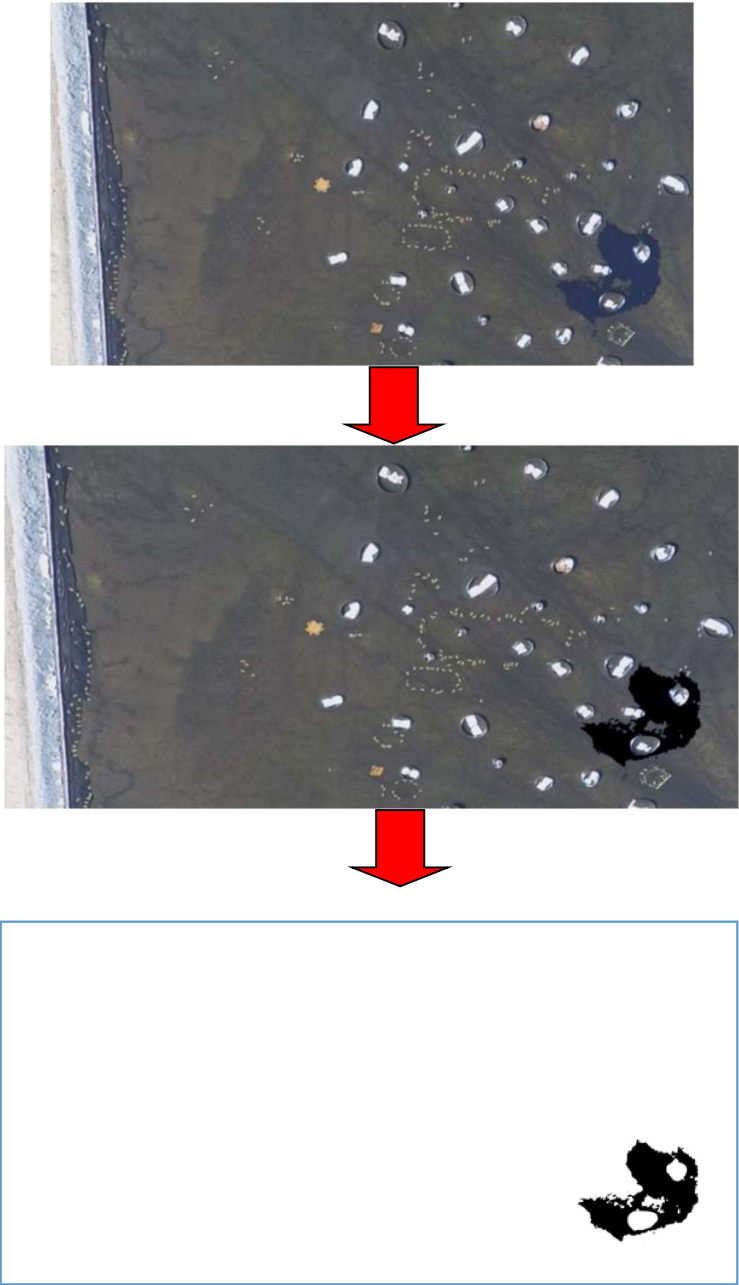
Figure 79: Digital transformation of aerial photographs to determine slick area

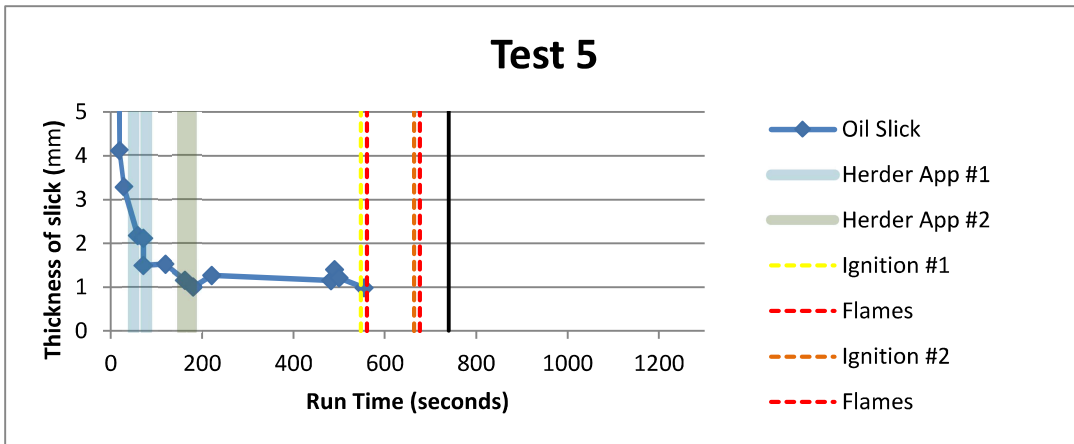
Figure 89: Thickness of Test 5 Oil Slick vs. Time

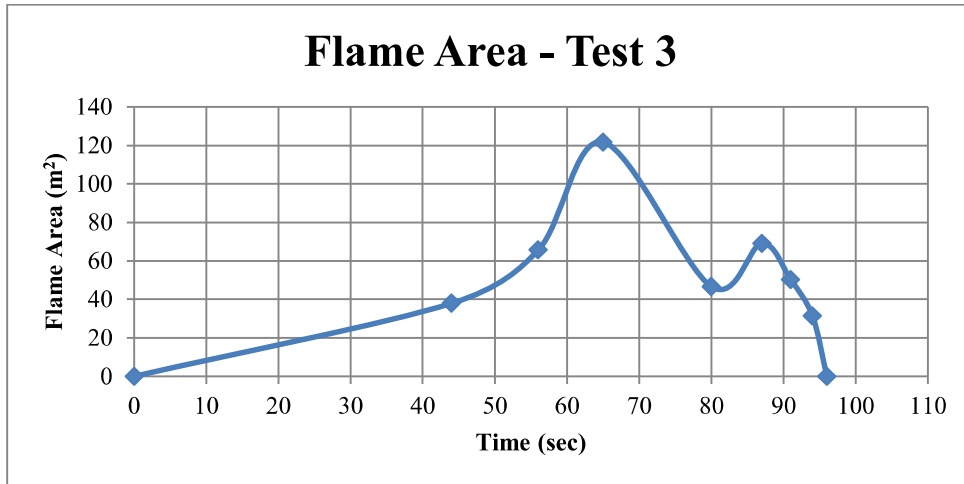
**Figure 90** shows the burn area data collected for Test 3 (151 litres of ANS herded with OP-40). Using Equation 2 with an area-time integration of 3800 m<sup>2</sup>s gives an oil volume burned estimate of 110 litres. Using the Maximum Burn Area approach results in an estimated burn volume of 120 litres. Based on this, the burn in Test 3 resulted in the removal of approximately 70 to 80% of the oil.

Figure 90: Flame area data for Test 3

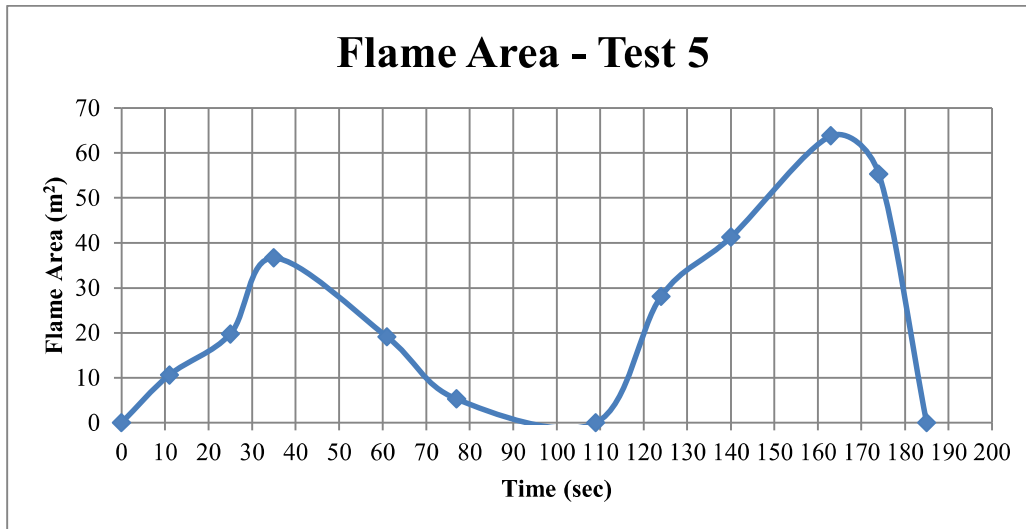
**Figure 91** shows the burn area data collected for Test 5 (154 litres of ANS herded with TS6535). Using the Integrated area-time approach with a value of 1500 m²s for the first burn and 2900 m²s for the second burn gives a total oil volume burned estimate of 130 L. Using Equation 3 results in an estimated burn volume of 40 litres for the first burn and 75 litres for the second for a total of 115L burned. Based on this, the burn in Test 5 resulted in the removal of 75 to 85% of the oil using herding and burning applied from a helicopter.

Figure 91: Flame area data for Test 5

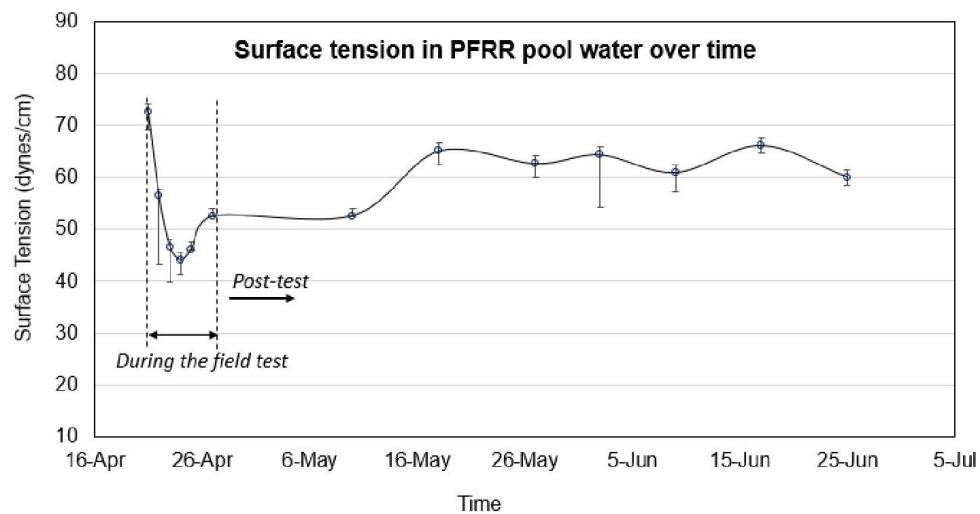
Chemical herders reduce the surface tension, thus surface tension values act as a surrogate for herder concentration values in the water column. Lower surface tension values indicate higher herder concentrations. Surface tension values are routinely used in laboratory and field scale herding studies/operations to quantifiably estimate the herder concentrations. Thus, for the chemical herder mediated in-situ burning study, samples were systematically collected for surface tension measurements before the test commenced (to collect baseline data), during the tests and after the tests; to track herder concentrations and subsequent post-test degradation. The results of these measurements are presented in Figure 1.

Figure 1: Surface tension results from Poker Flat test basin (2015)

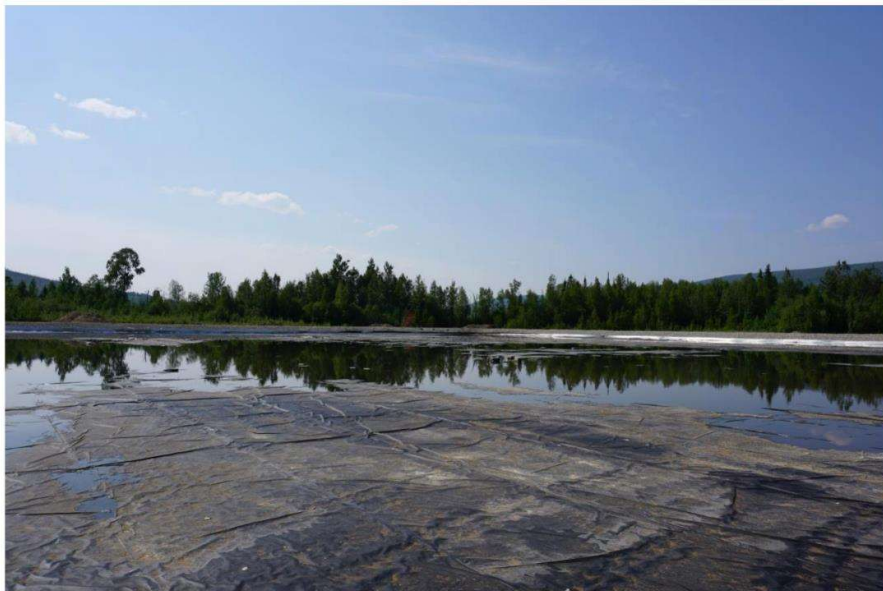
Our team has visited the basin weekly following the tests to collect samples and make observations. During those visits, we noted that there is no visible petroleum sheen, and also that the basin water level has dropped considerably due to evapotranspiration. On our 7/4/15 visit, we noted that approximately 40% of the basin area was dry, with the remaining water existing only in the low spots. Given that the basin bottom is relatively flat, the residual water likely accounts for much less than 10% of the approximately 400,000 gallons present during the April field tests. A picture of the basin on that 7/4/15 visit is presented in Figure 2.

Figure 2: Basin condition on 7/4/15.

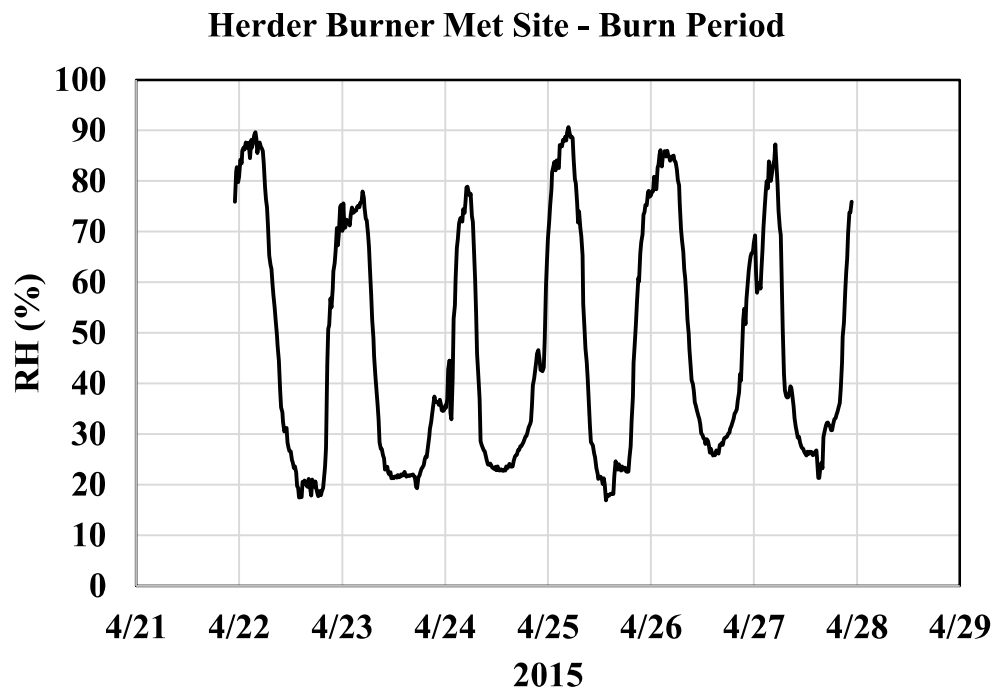
Figure C-2: Relative Humidity During Testing

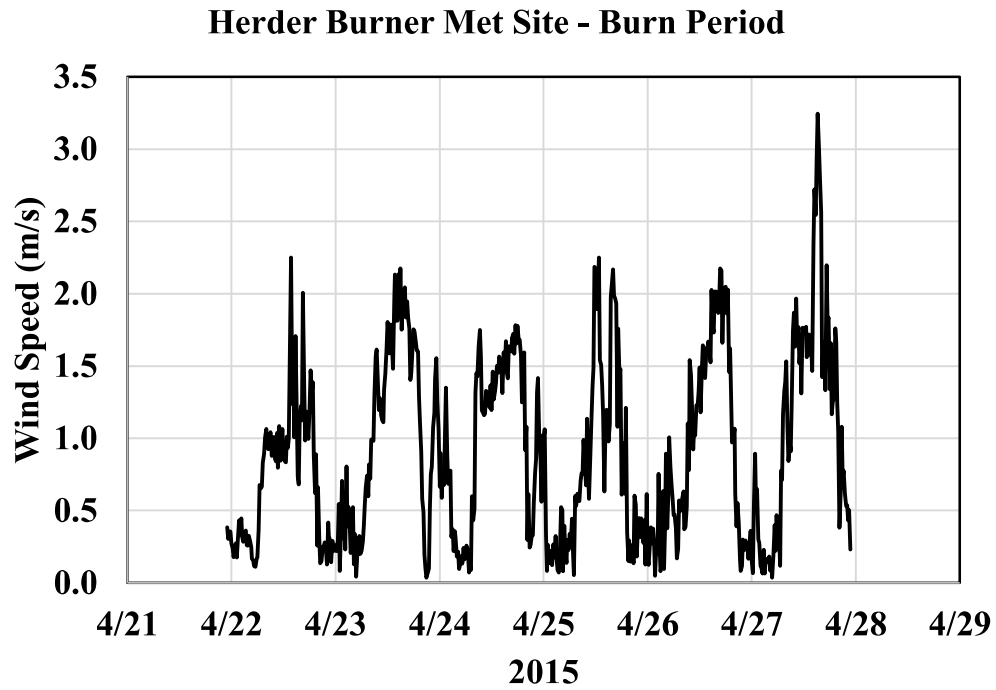
Figure C-3: Wind Speed During Tests

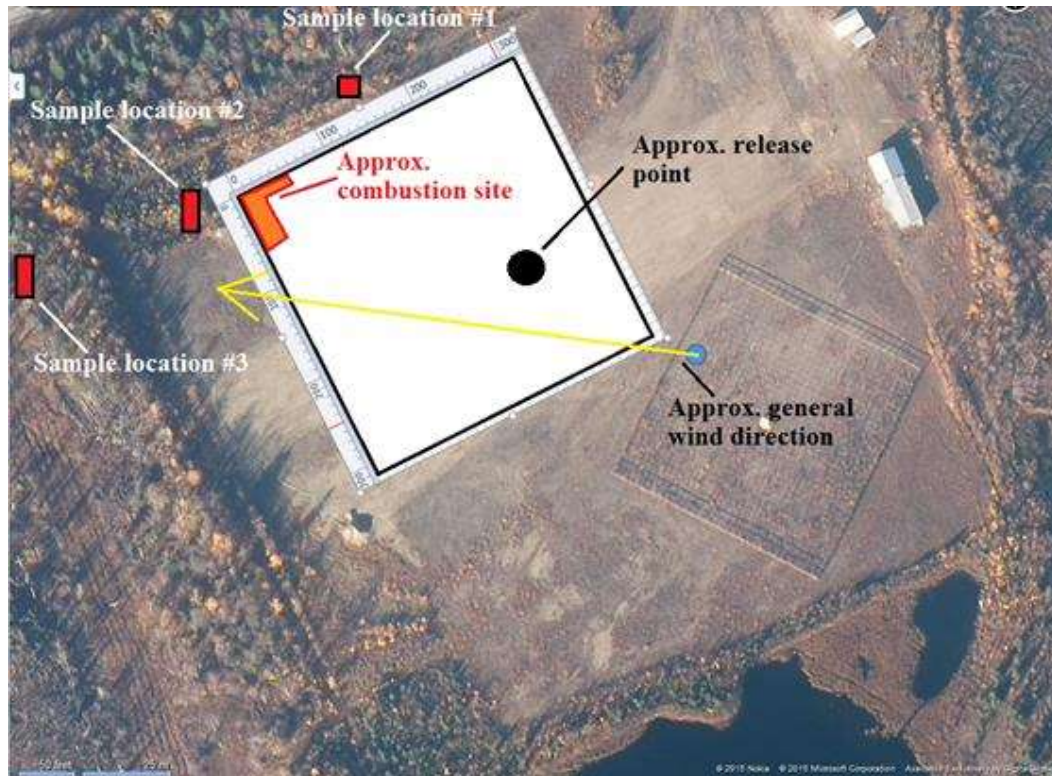
Figure D-2: Locations of Air Samplers

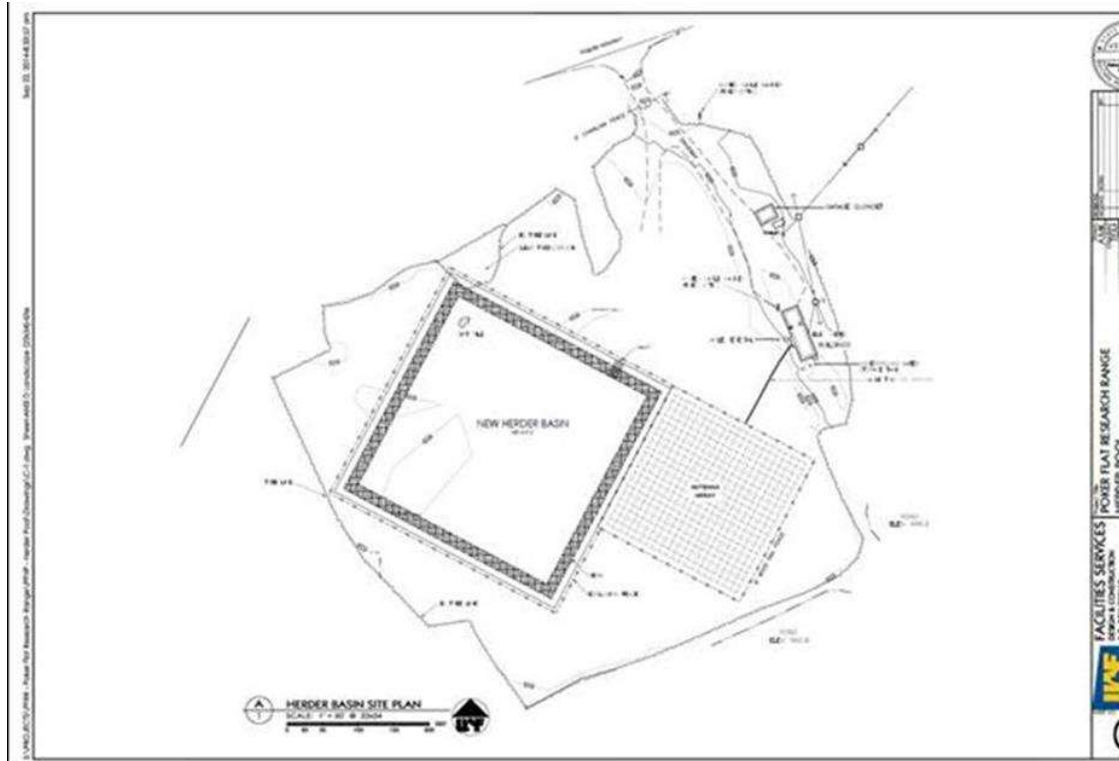
Figure E-3: Herder Test Basin Design and Site Layout

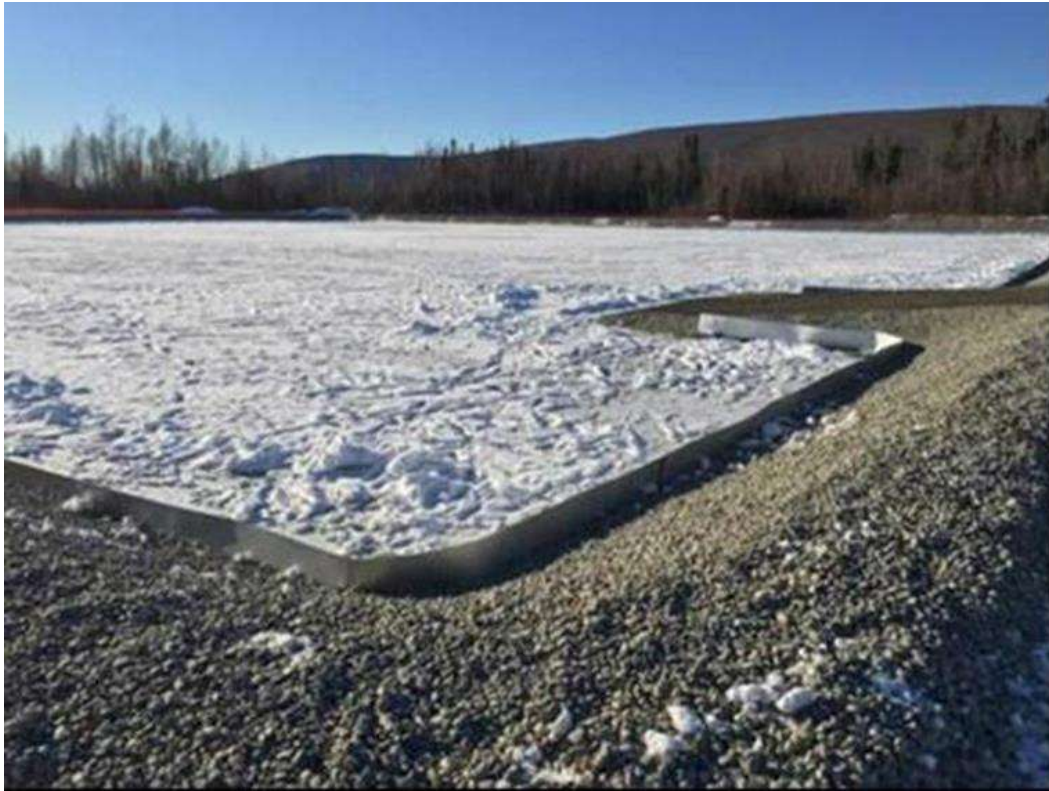
Figure E-5: View of Completed Basin from East Corner Facing West 10/9/14

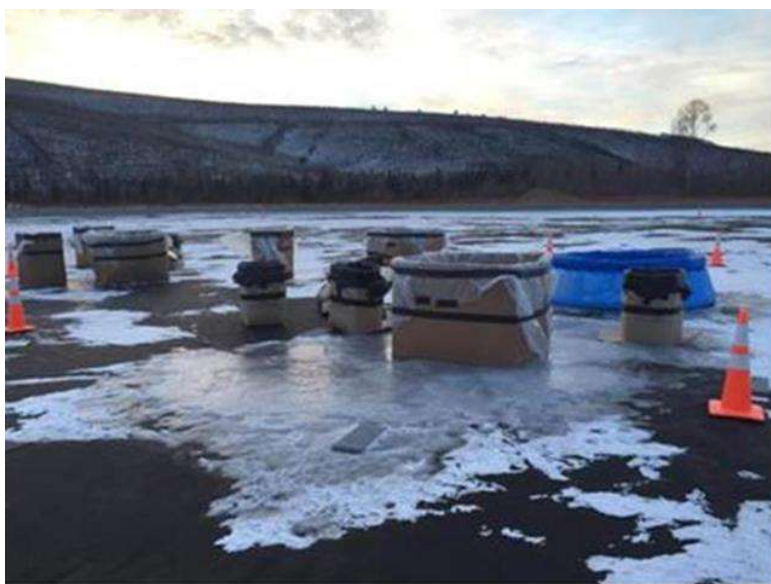
Figure E-7: Iceberg Form Tests Using Boxes and Inflatable Pool

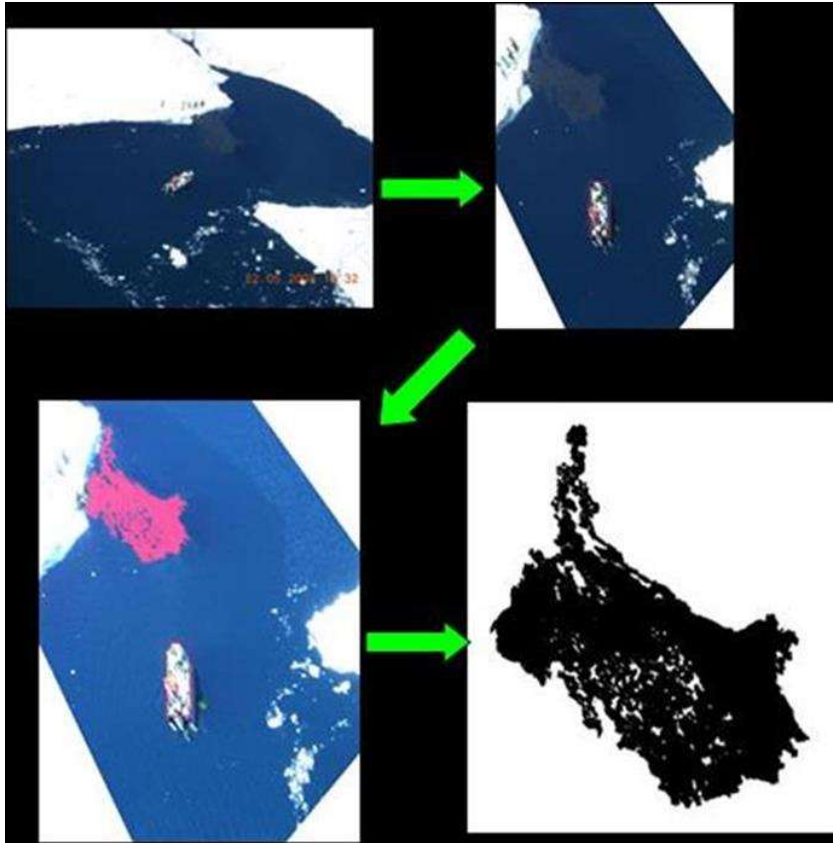
Figure E-12: Digital Transformation of Aerial Photographs to Determine Slick Area

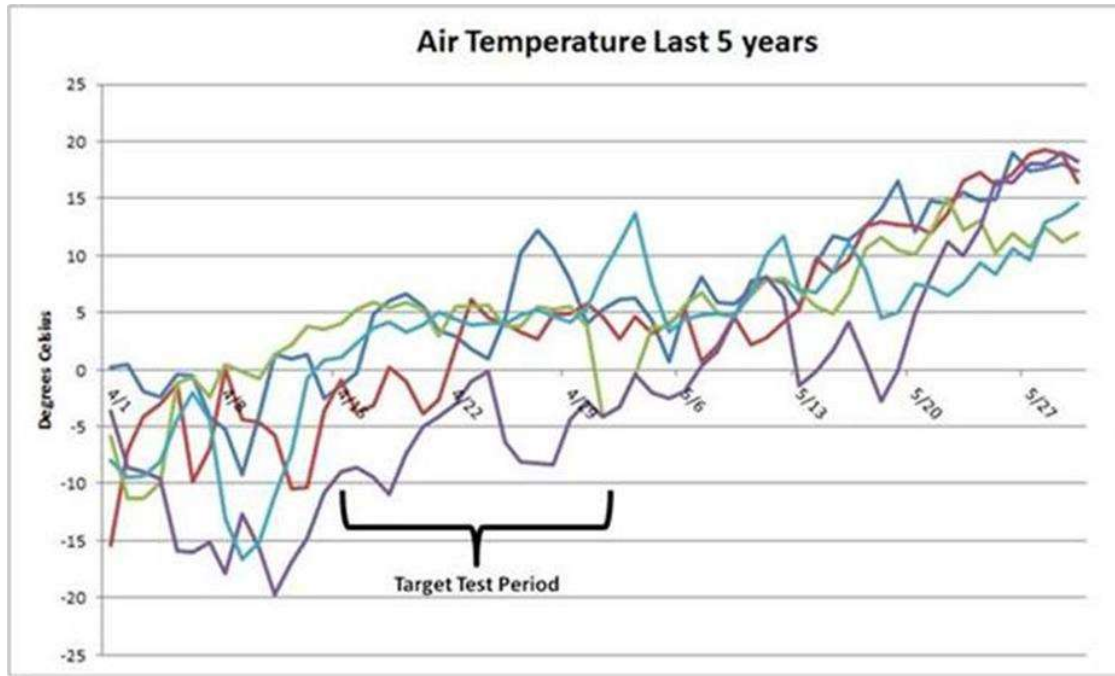
Figure E-13: Average daily temperature at test site over last five years – April 1 to May 31

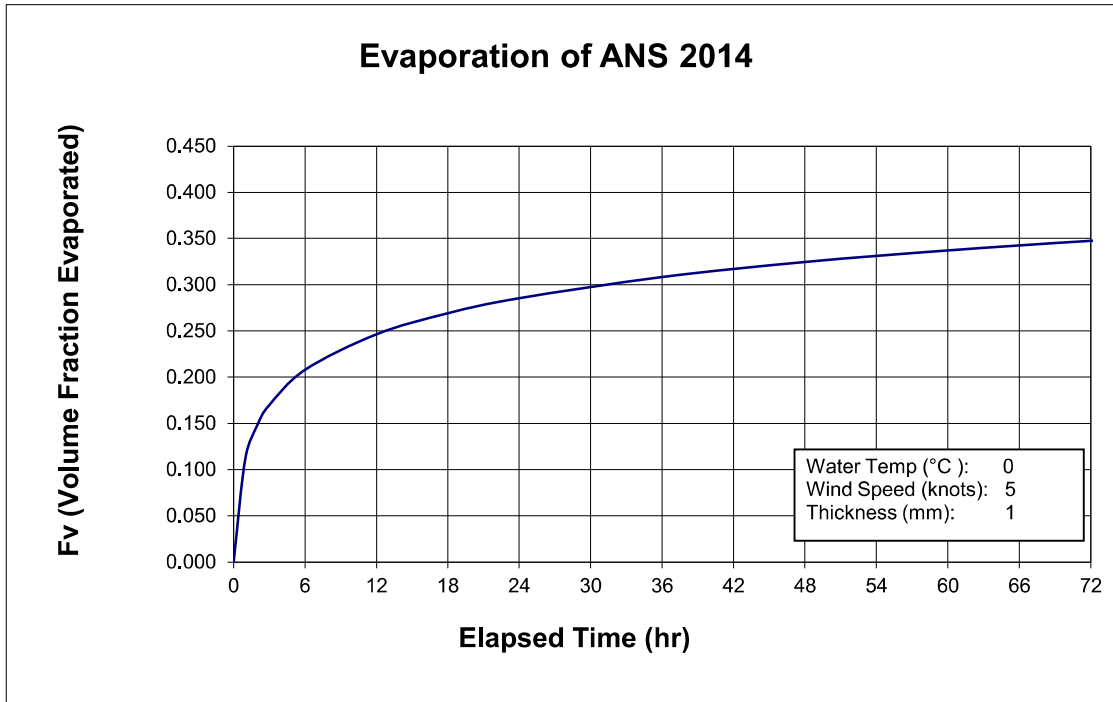
Figure G-1: Evaporation of ANS 2014

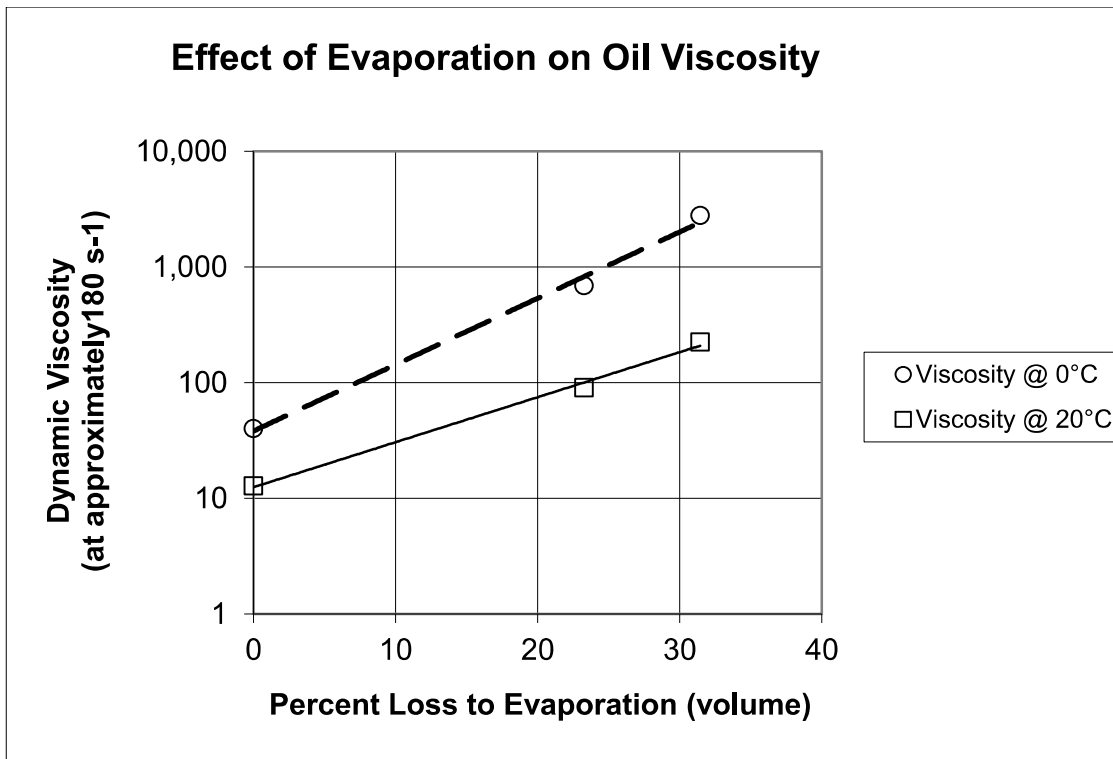
Figure G-2: Effect of Evaporation on Oil Viscosity

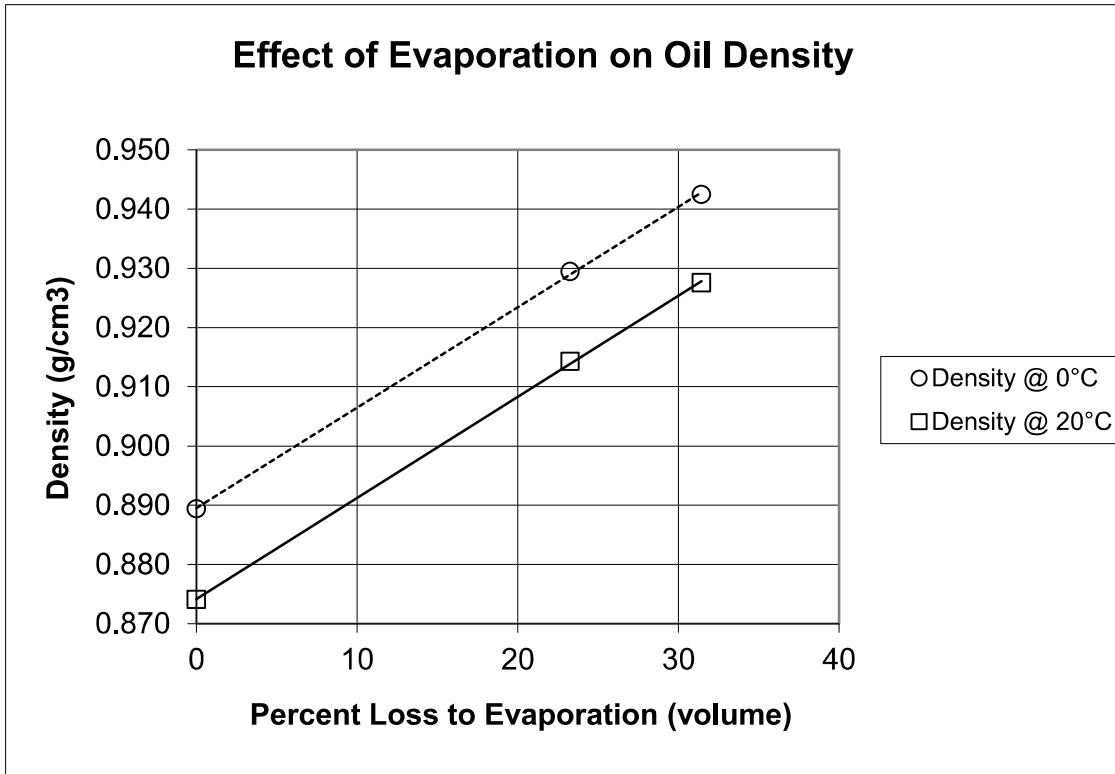
Figure G-3: Effect of Evaporation on Oil Density

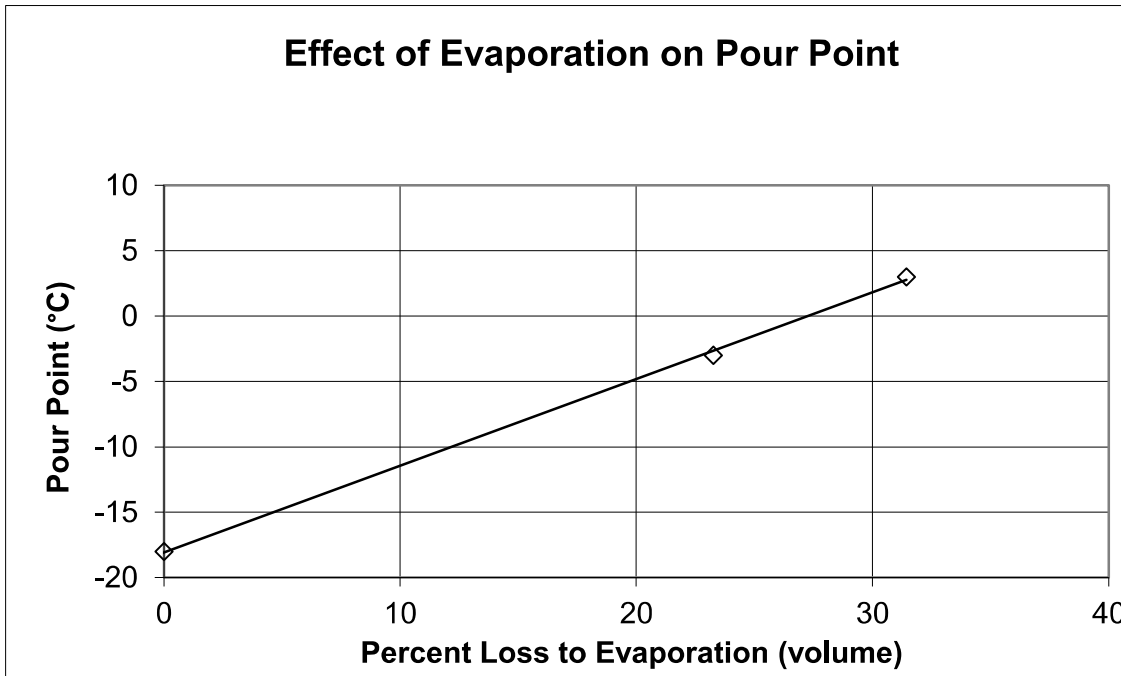
Figure G-4: Effect of Evaporation on Pour Point
