DESMI Ro-Clean A/S
Hestehaven 61, DK-5260 Odense S, Denmark

S.L. Ross Environmental Research Ltd
200-1140 Morrison Dr.
Ottawa, ON, Canada, K2H 8S9

IOGP JIP RESEARCH PROJECT 6:
INTEGRATED IGNITER/HERDER APPLICATION SYSTEM

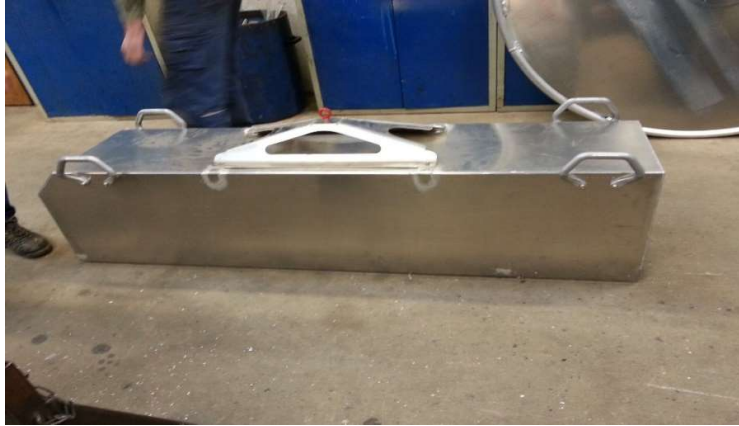
Figure 4. First generation launcher module before field mods.

DESMI developed the module to be self-contained which also had the nozzle arrangement, camera, conveyor system and batteries to operate the conveyor and flow control valve (Figure 4). All controls had to be wireless due to the difficulty of running a co-axial cable and hose from the winder module in the aircraft. The wireless control system (Figure 5) was developed by CAVOTEC, a German company.

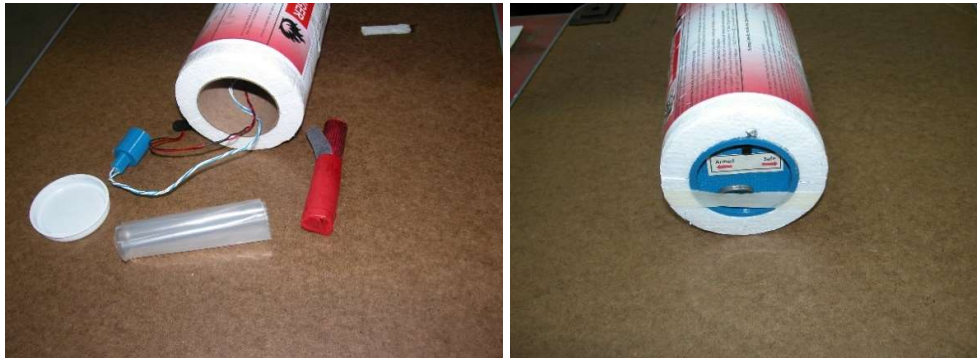
Figure 6. Igniter Details of end cap and contents. (Control end left – Igniter end right)

Tests at the CAD test facility of the initial design (Figure 6) in February 2016 indicated that it met the original design criteria. Further tests at SL Ross - as described later in Section 5.0 -indicated a number of design and assembly features that needed to be addressed. Section 5.5 addresses recommendations derived from the SL Ross testing.

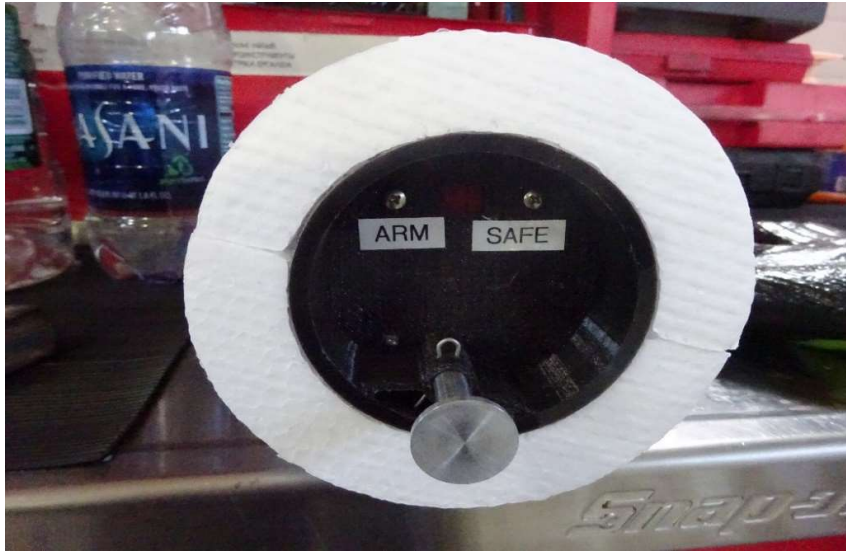
Figure 7. Revised Igniter Modification 3

Changes made include:

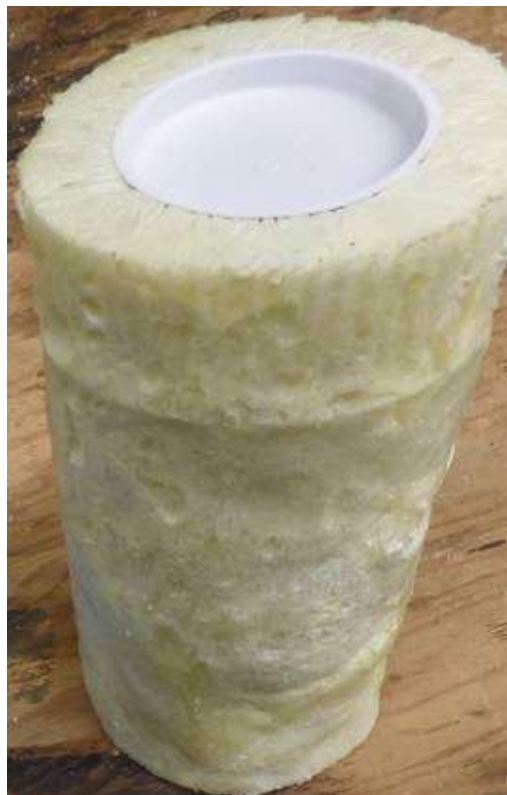
Figure 55. Surrogate igniter

The weight of the surrogate igniter (starting weight 568 g) was maintained to within 5% of the original igniter weight (567 g) during subsequent runs. If the surrogate gained too much weight through water ingress, the surrogate was replaced with another and the starting weight of the new surrogate was made to be 567 ± 5 g.

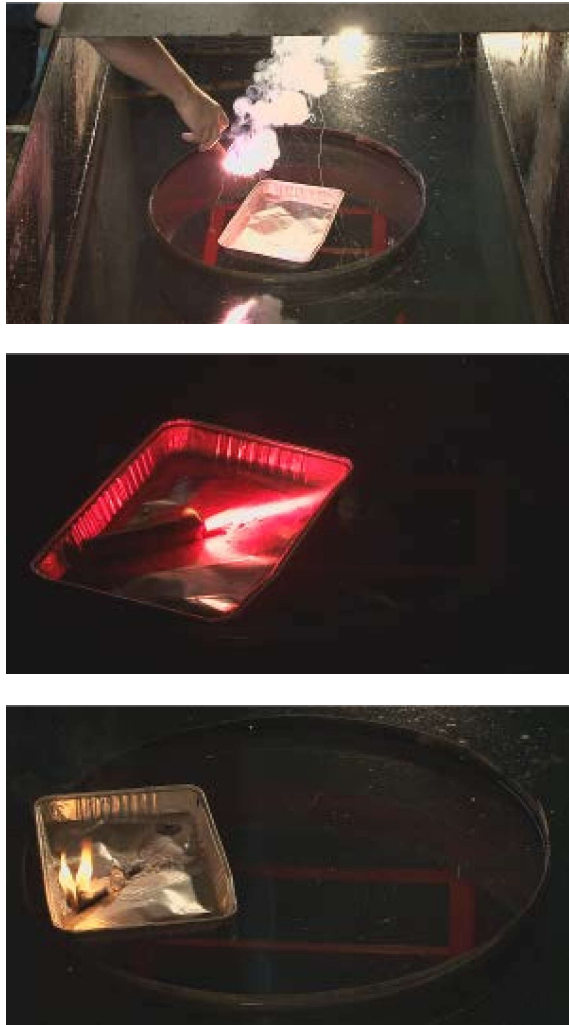
Figure 62. Test #6b Flare test in pan

The flare from Test #6 was manually ignited to confirm that the flare was in good working condition and provide some visual representation of the burning characteristics of the flare (see Figure 62).

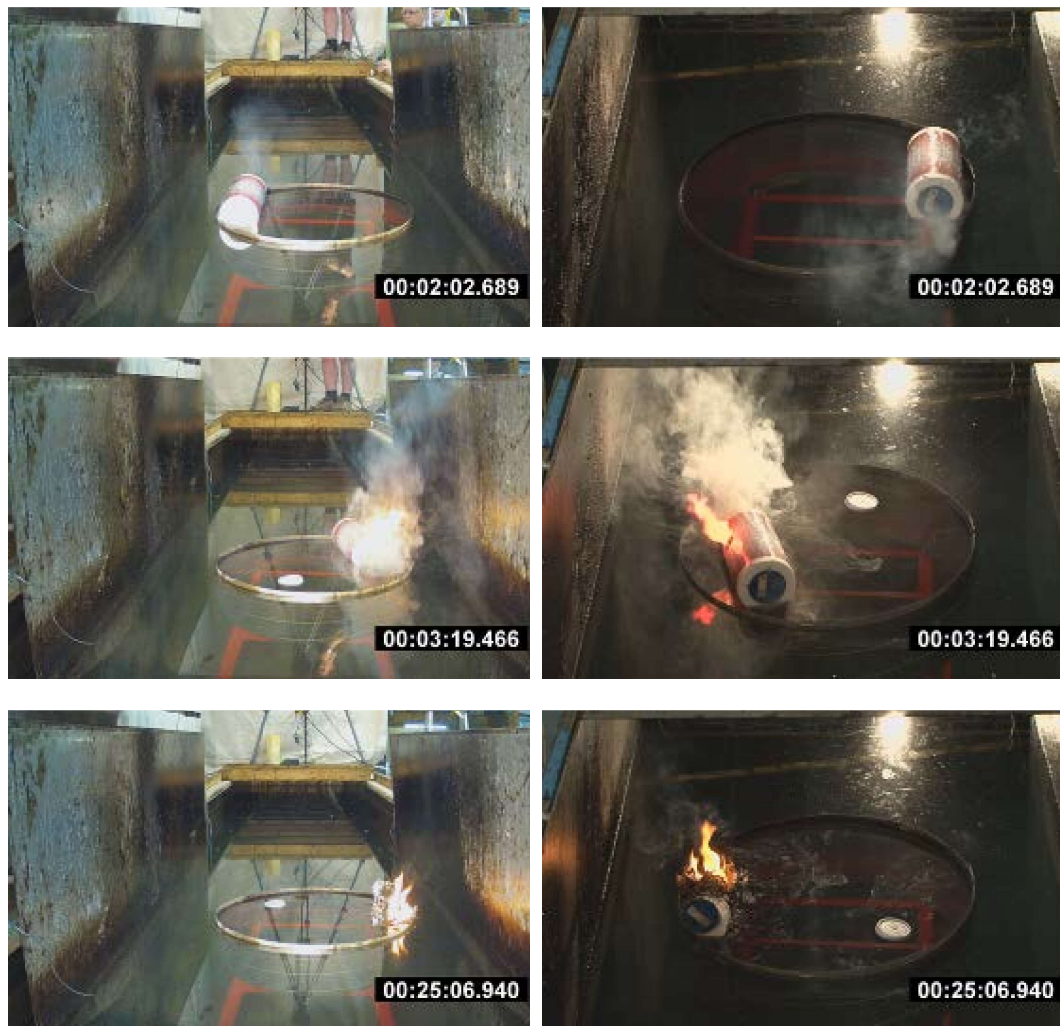
Figure 63. Test #7 Simple igniter test

This simple igniter test was a repeat of the previous test – no gelled fuel or oil was provided for combustion. The igniter was triggered to ensure that the timing mechanism was working, and that the integrated flare would ignite. Frame grabs from the two cameras at three points are shown below in Figure 63. The first pair shows the initial presence of smoke indicating the triggering mechanism has successfully deployed. The second pair shows the first flame outside the igniter body. The third pair shows the burning gelled fuel.

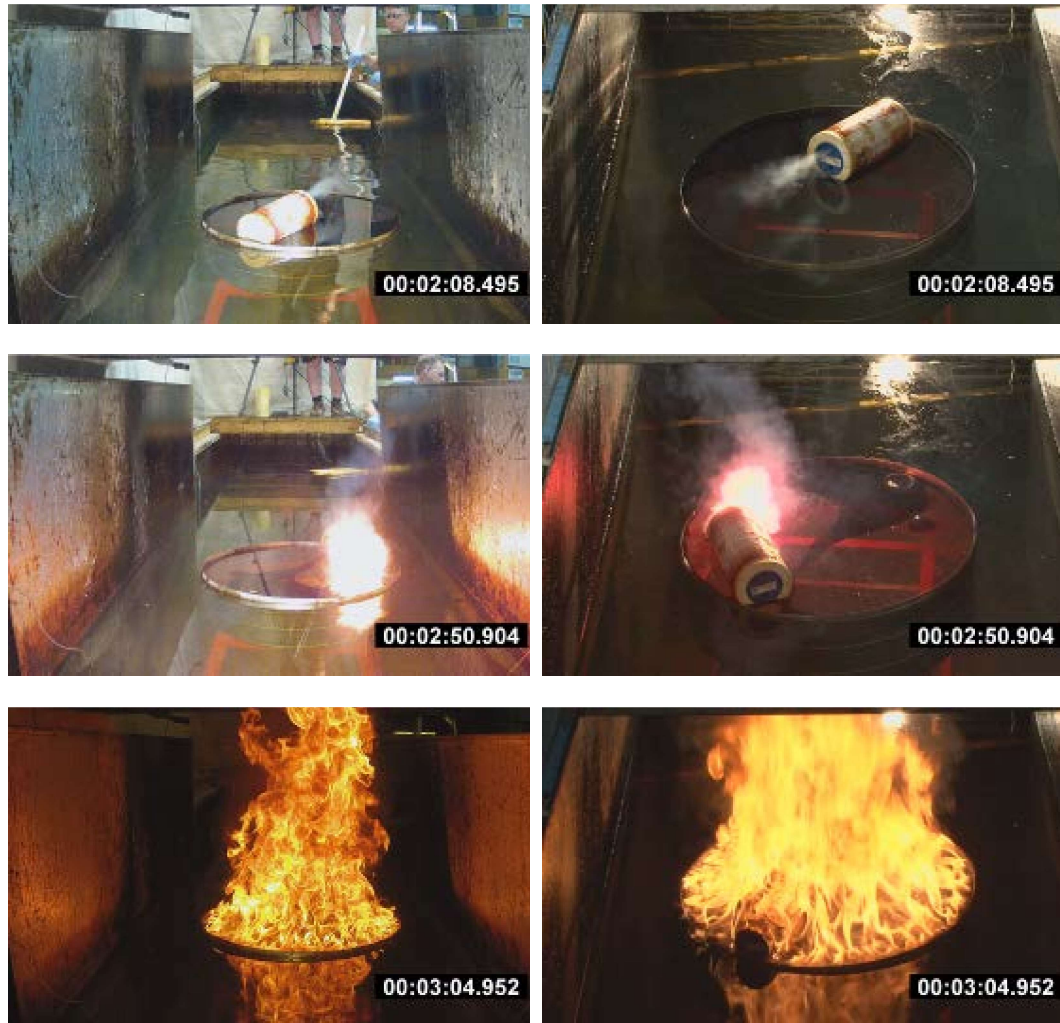
Figure 64. Test #8 Successful burn with premium gasoline

Test #8 included premium gasoline as the primary component of the gelled fuel, and fresh North Star crude oil comprised the slick. Smoke was detected shortly after the 2 minute mark, and the white end cap blew off approximately 12 seconds later. The bag of gelled gasoline remained confined to the interior of the igniter as the flare continued to burn. It was approximately 40 seconds from the initial detection of smoke from the control cap of the igniter that the crude oil finally ignited and began to burn (see Figure 64).

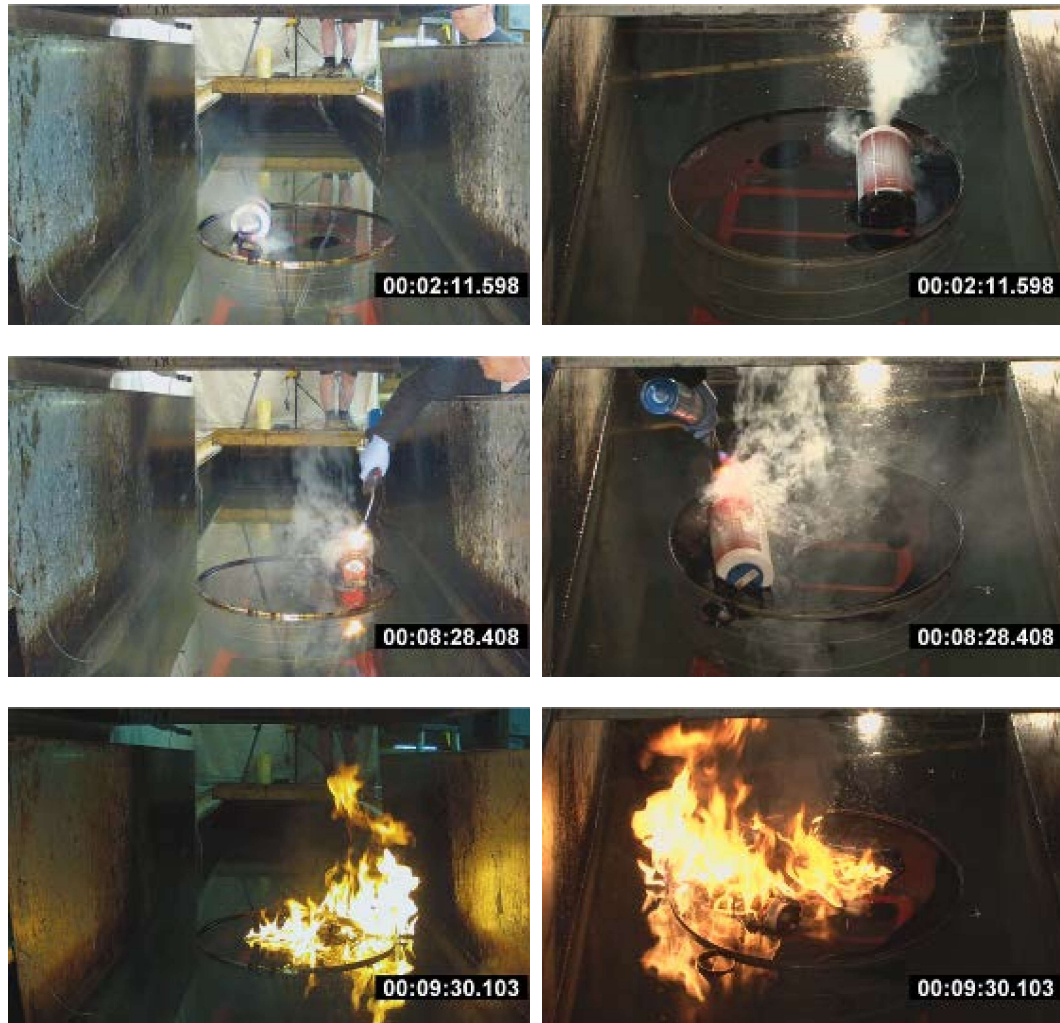
Figure 66. Test #10 Unsuccessful igniter test: crude lit with propane torch

Test #10 included AVGAS (100LL) as the primary component of the gelled fuel, and weathered Kuparuk crude oil as the slick. Smoke was detected shortly after the 2 minute mark, exiting primarily from the blue control plug (with the on/off switch and starting pin). The igniter smoked, but the end cap did not blow off until approximately 35 seconds after firing. Intense red glow from the flare was seen through the end, and the bag of gelled gasoline was just in front of the flare but the gelled fuel did not catch fire: neither did the crude oil. By the 5 minute mark the interior of the igniter was glowing red/white, yet no flames were seen to be exiting the body of the igniter. At approximately 8 minutes and 25 seconds the ignition was deemed a failure, and the oil was ignited by a hand-held propane torch (Figure 66).

Problems also occurred with the igniter failing to ignite the oil on two occasions, Test #9 and Test #10. Both of these used AVGAS (100LL) gelled using the recipe concentration that appeared to work well during the lab scale gelling experiments performed earlier (specifically 0.15 g/10 mL fuel). These experiments showed that the gelling agent was particularly effective on AVGAS; compared with some other fuels tested, and was producing a highly gelled product that did not flow easily. The solution employed to solve this was to reduce the gelling concentration by approximately half and intentionally achieve a loosely gelled fuel. Additionally, the internal configuration of the igniter was modified to have the bag of gelled gas right at the end of the flare, as opposed to being wrapped around it. Care was also used not to overfill the gelled fuel bags, avoiding compacting the bag too severely when the white end cap is installed. If too full, the plastic bag can be damaged when pushing it into the cartridge.

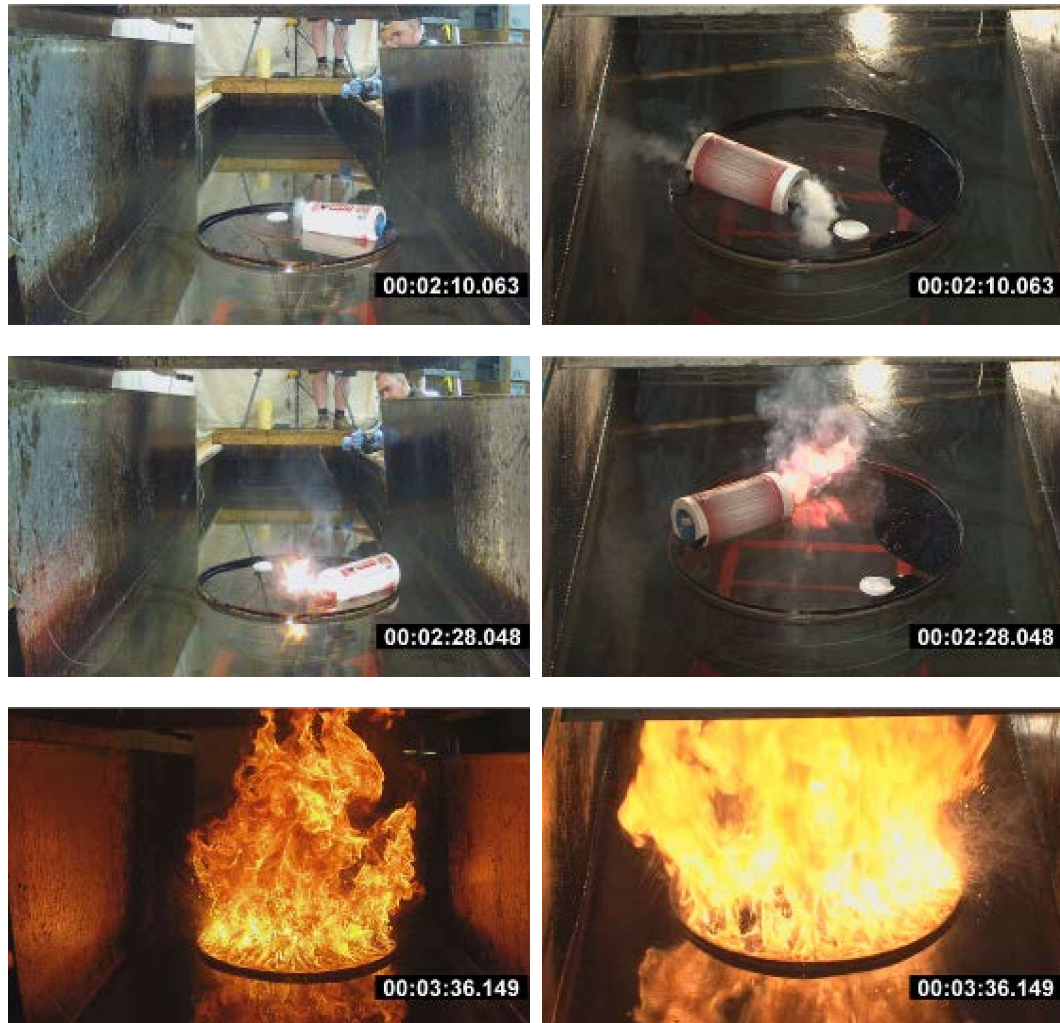
Figure 68. Test #12 Successful burn with Jet A1

Test #12 (Figure 68) used Jet A1 as the main component of the gelled fuel, using the recipe from Test #11 to create a semi-gelled liquid. The oil slick was weathered Endicott crude (1.35%). Modified gel placement was used (gel bag all at one end, with the flare embedded at opposite end of the igniter). Smoke was detected immediately following the end cap blowing off at 2:10. It took approximately 18 seconds before the heat from the flare melted the partially ejected bag of gelled fuel which then burst into flames. Burning gelled fuel spread over the water within the containment cell, contacting the crude oil which then began to burn too.

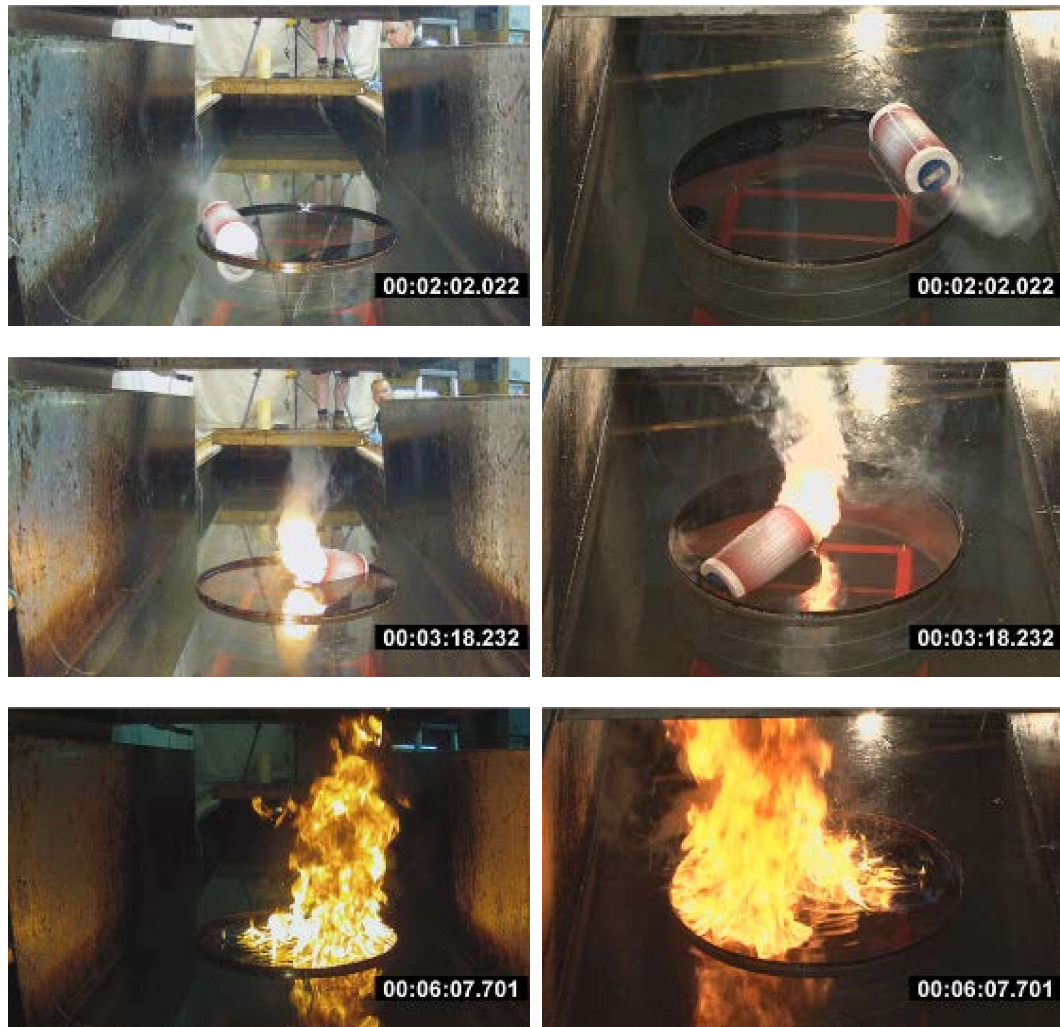
Figure 69. Test #13 Successful burn with premium gas

The final test included premium gasoline as the loosely gelled fuel. Endicott weathered 6.17% was used as the crude oil. Smoke was detected at the 2:02 mark of the test, and began coming out of the blue control end of the igniter. It was not until 2:35 that the white end cap popped open slightly, allowing smoke to come out the end of the igniter. Over the next 10 seconds the igniter developed a bit of a list, possibly due to the more liquid component of the gelled fuel running back to the blue control end of the igniter. Ultimately the igniter settled into a position angling the white end cap slightly in the air. By 3:07 the end cap finally ejected and the edge of the gelled fuel bag can be seen approximately 2cm outside the opening. Within the igniter, the flare can be seen intensifying and in 11 seconds the gelled fuel ignites. Flames quickly spread to engulf both ends of the igniter. The igniter slowly rotates in the contained area, and it is not until 3:46 that flames from the igniter begin to impinge on the slick. By 4:20 a corner of the slick appears to catch fire. By 4:45 approximately half of the oil slick is on fire, and by 6:04 most of the area is burning intensely (see Figure 69).

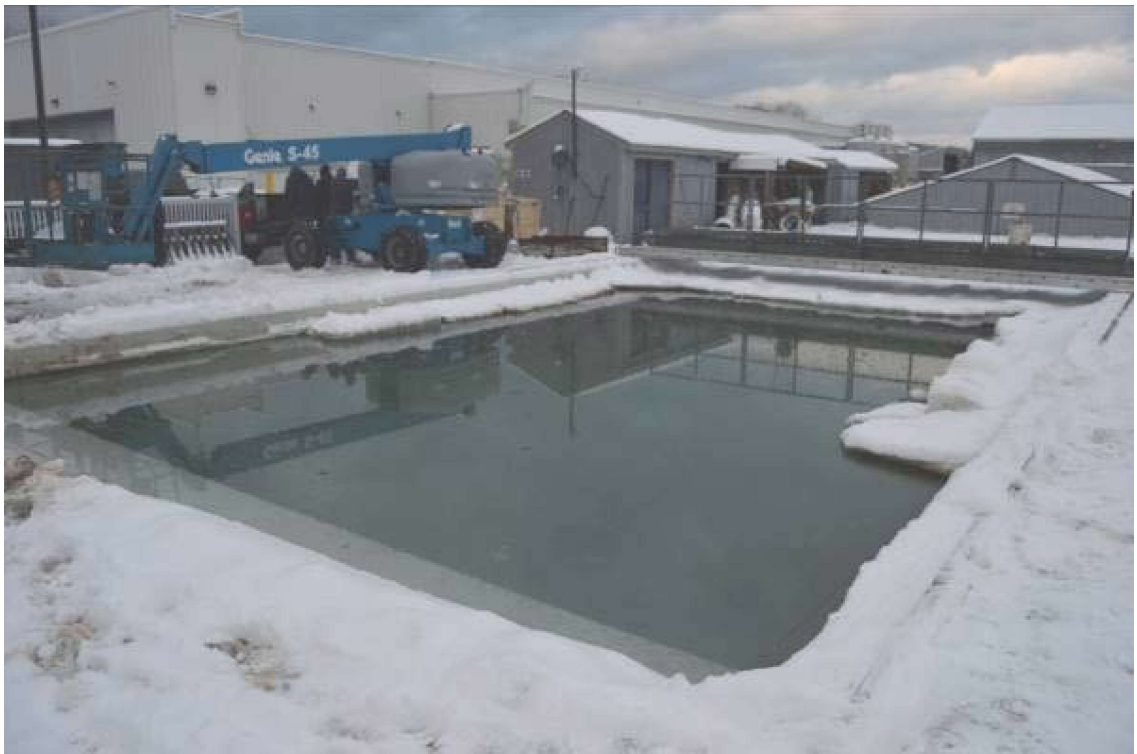
Figure 70 Geophysical Research Facility Outdoor Basin with Ice Removed

The tests were conducted in the Geophysical Research Facility (GRF) outdoor basin at CRREL (Figure 70). At the time of the testing, a cover of ice had been excavated from the surface of the basin and all but the edges of the tank were open water. The basin water was 20‰ brackish water.

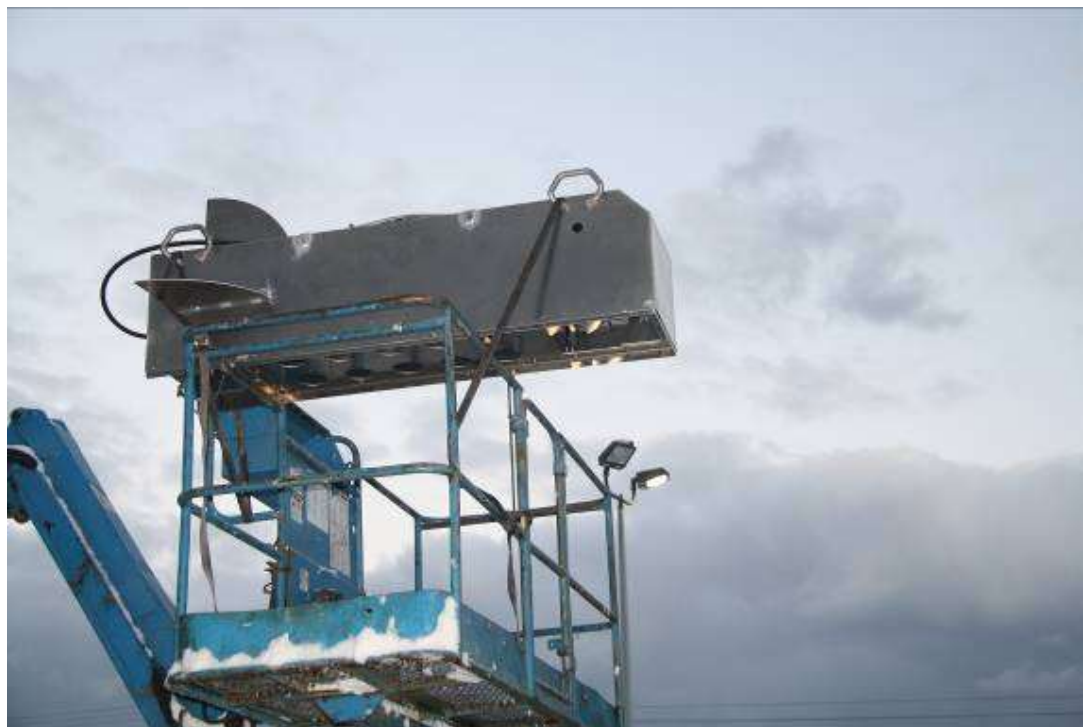
Figure 75 IIHAS strapped to person-lift basket and loaded with activated igniters

The first step in each test was to ensure that the IIHAS was securely strapped to the safety rails of the person-lift basket, had been powered up, and had been loaded with one or more activated igniters (Figure 75).

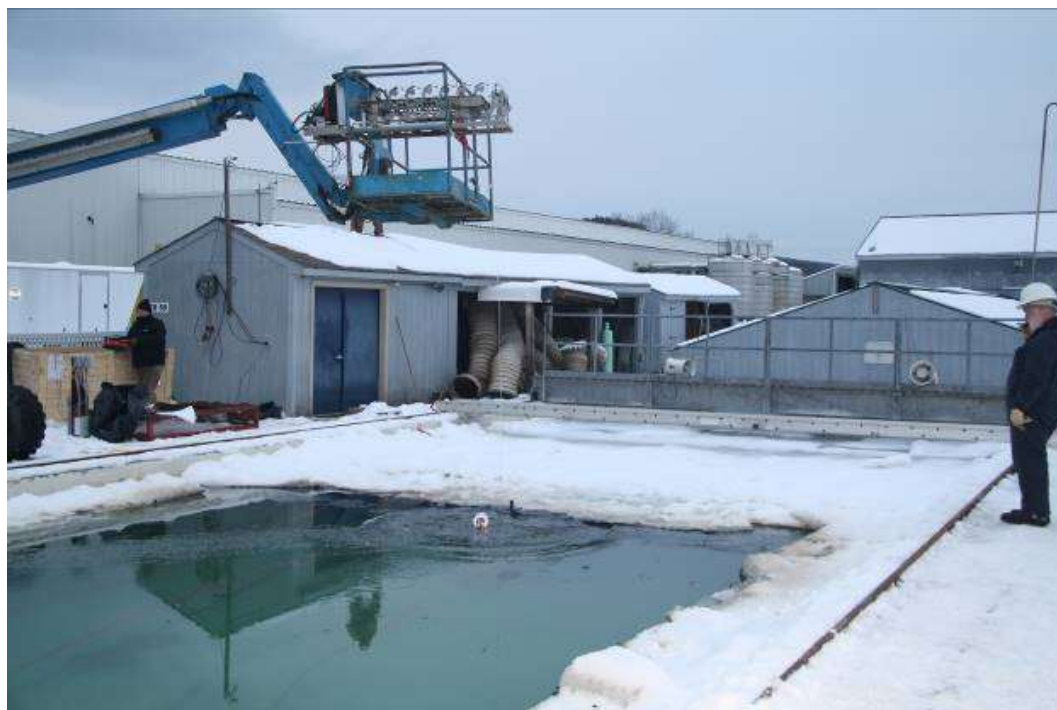
Figure 78. Igniter landing on slick

In order to minimize drift of the test slick due to winds, the oil was released from the upwind side of the basin once the IIHAS was loaded and ready to function. Once the slick was poured, the person-lift was raised to the specified test height (5 or 10 m – 15 or 30 feet, as measured by a weighted string attached to the basket) and the IIHAS positioned over the herder slick (Figure 77). Next, the IIHAS was activated and an igniter released to fall into the slick, the slick allowed to re-herd and the igniter activated (Figure 78).

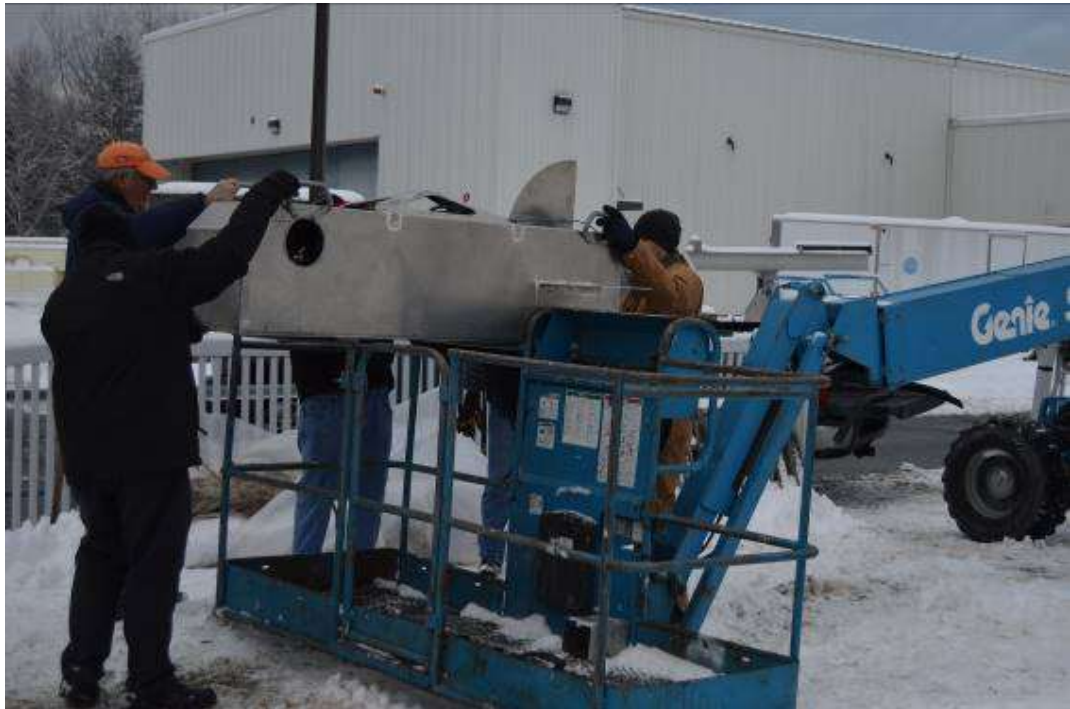
Figure 80 Loading IIHAS on to person lift for pre-test (note access port cut into side)

After the field modifications to the IIHAS to allow access for igniter loading and positioning (Figure 80) the system was strapped onto the basket of the person lift to test its operation. One igniter had the original firing ring replaced with the new steel firing pin, was loaded into the IIHAS and activated. The IIHAS was then raised, swung out over the basin and activated to release the igniter. The action of the IIHAS successfully pulled the firing pin and the activated igniter fell onto the water (Figure 81). The igniter floated on the water with the warning light blinking for 1 minute 54 seconds, then the flare ignites and the white end cap pops off (Figure 82). After another 58 seconds, the gelled gasoline ignites (Figure 83).

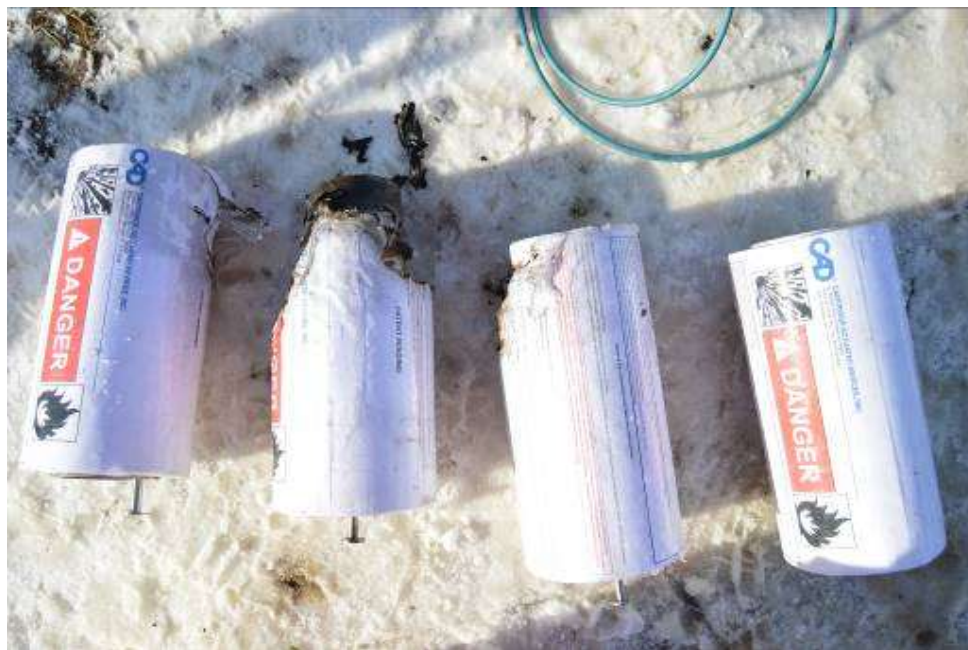
Figure 84 Igniter damage after Test 1 misfire (second from left went off)

For subsequent tests the cover of the IIHAS was removed and typically only one igniter was loaded at a time to prevent damage to nearby igniters if a pre-ignition occurred again.

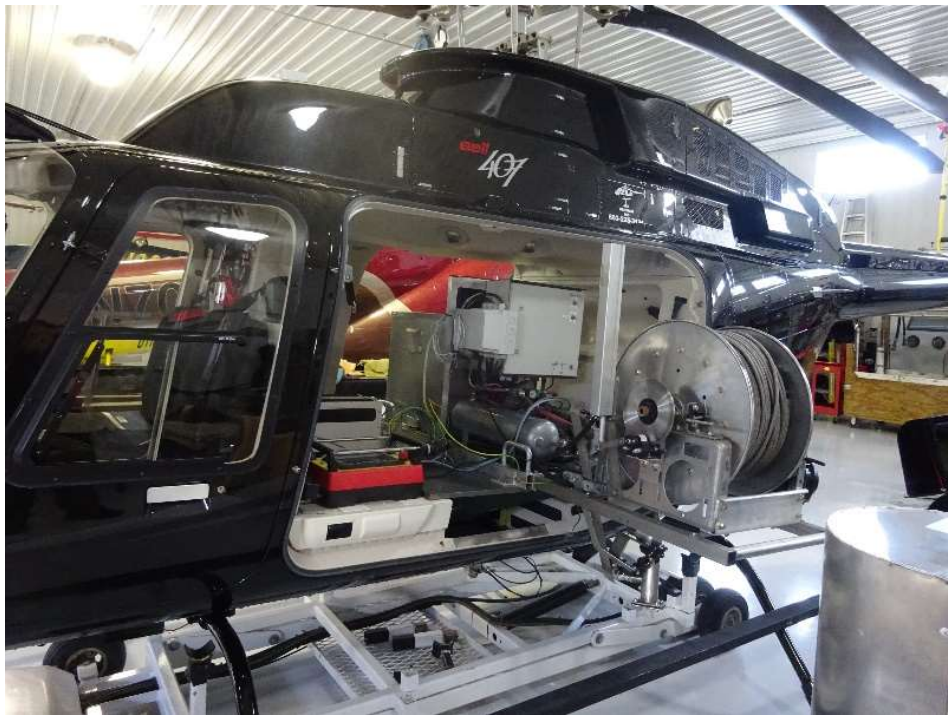
Figure 85. System installed in Bell 407.

OUTCOME: The system installation in the helicopter went very well (Figure 85). The skid in the helicopter worked well with some minor adjustments to satisfy center of gravity and balance required when flying with an external load. The pilot did not have a problem carrying the SIM launcher from a weight or airworthiness aspect. The spinning of the SIM in forward flight made deciding when to drop the cartridge difficult.

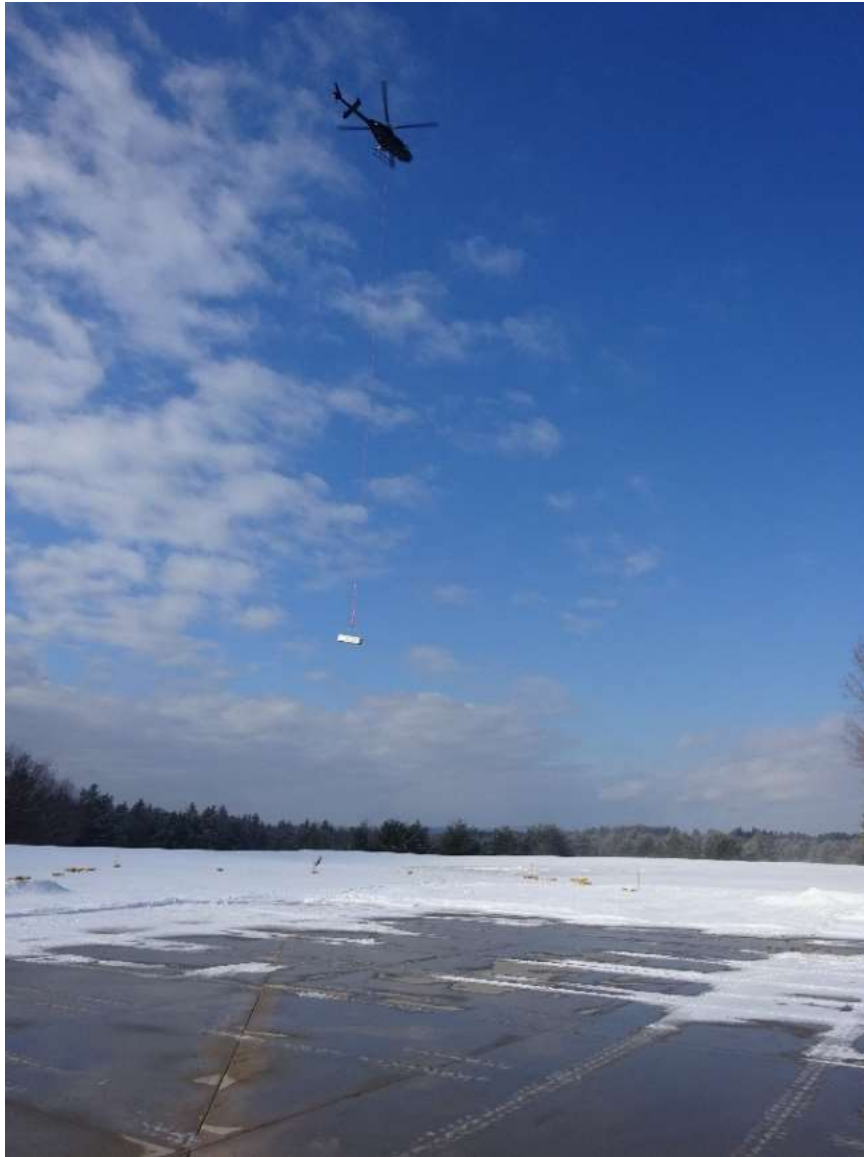
Figure 86. SIM in flight in original horizontal configuration.

OUTCOME: The launcher flying in the original horizontal orientation did not perform well due to continuous rotation that damaged the cable used to deploy it. This was due to the shape of the SIM (like a long box), the forward motion of the helicopter, and the rotor wash turbulence (Figure 86).

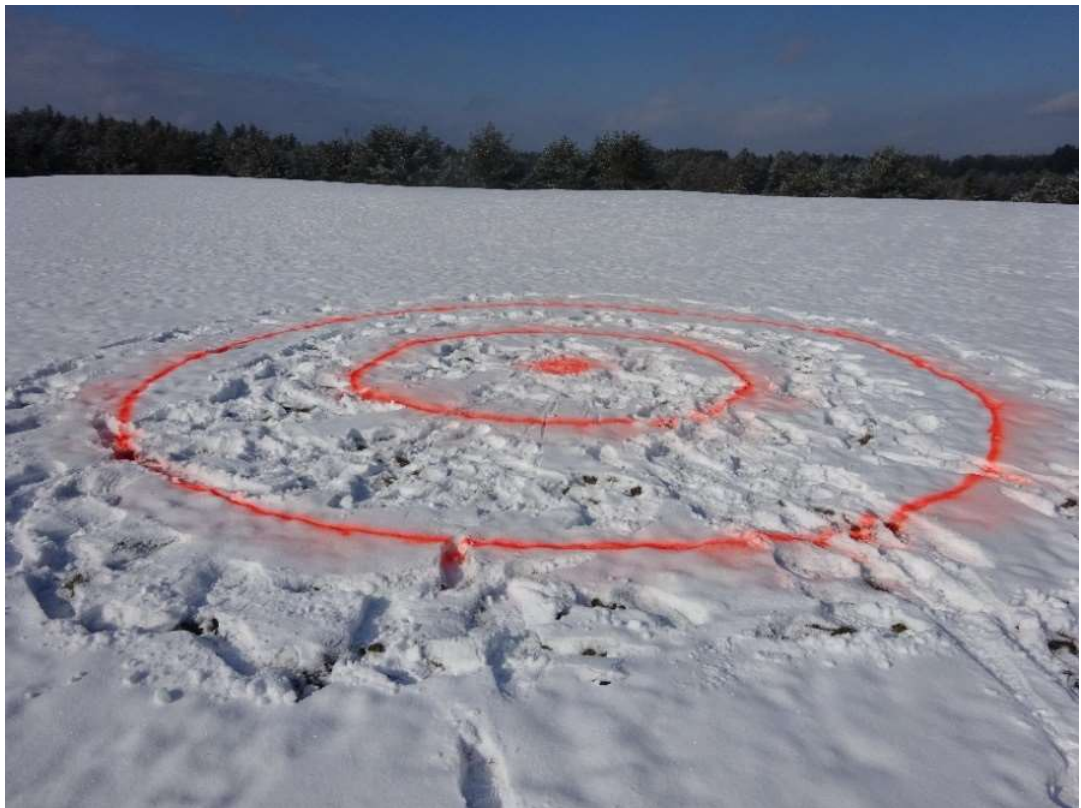
Figure 88. Igniter target on snow

Visual observations of the drop were conducted by observers (3 in total from different angles) from a distance as per the safety plan. The target was designated as orange spray paint circles of 10' and 20' diameter and a center bullseye (Figure 88), with measurement taken if the igniter fell outside of the target. Fifteen cartridges were dropped with several dropping inside the 10' diameter circle and most dropping inside the 20' diameter circle. The one cartridge that jammed was launched by moving the track slightly in reverse and then forward and it dropped about 60' from the center point. It should be noted that the cartridges sometimes bounced away several feet from their initial impact point and the rotor wash also moved them further when making the next pass over the drop target. Therefore, the observations of the initial drop point were used to assess the drop effectiveness.
